ELECTRICAL SAFETY AUDIT REPORT

PREPARED FOR

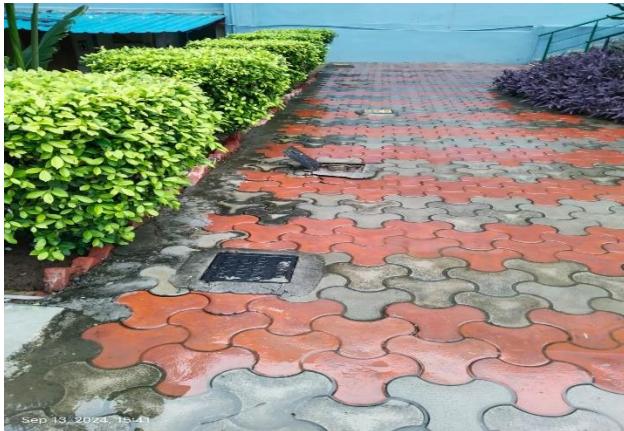
Solar & Admin Lift Earth Pits
(Above the ground, No Tagging)

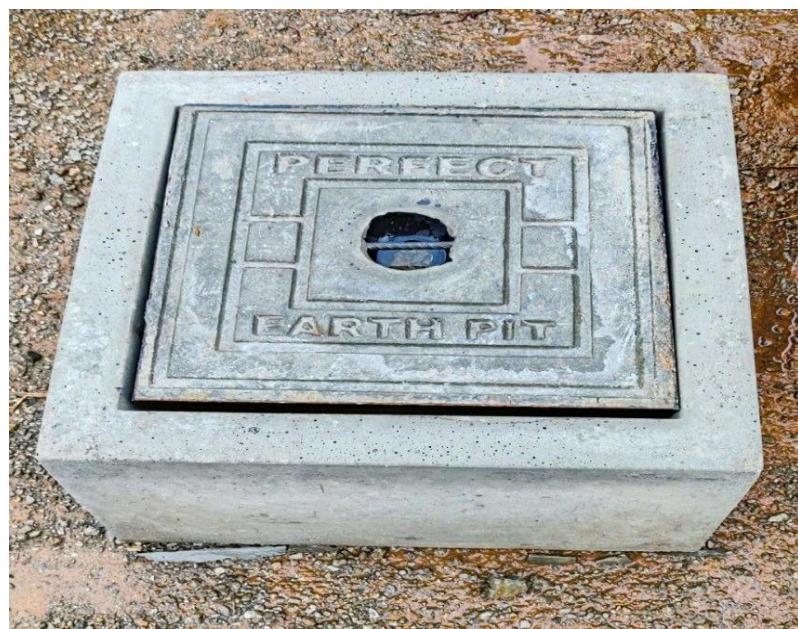
Sample Illustration for designing Earth Pit Cover

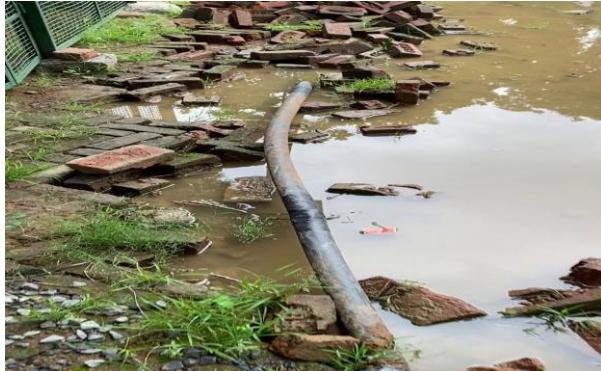
TR Switch Yard	Transformer Outgoing wires is kept above the ground and have cracked insulation which is covered with regular insulation tape	It should be supplied through the trench. Need Proper Insulation

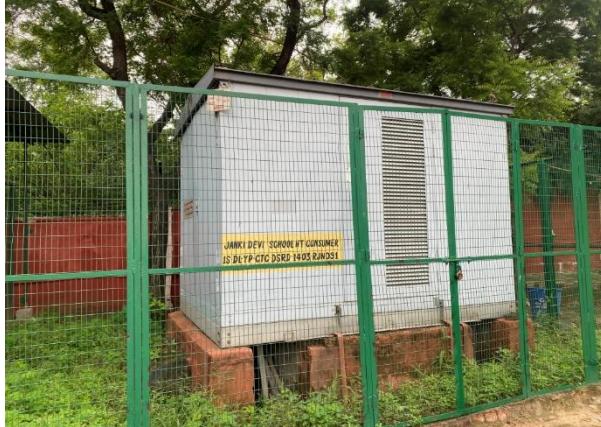
TR Switch Yard	Grass in Transformer Switchyard	Cleaning required

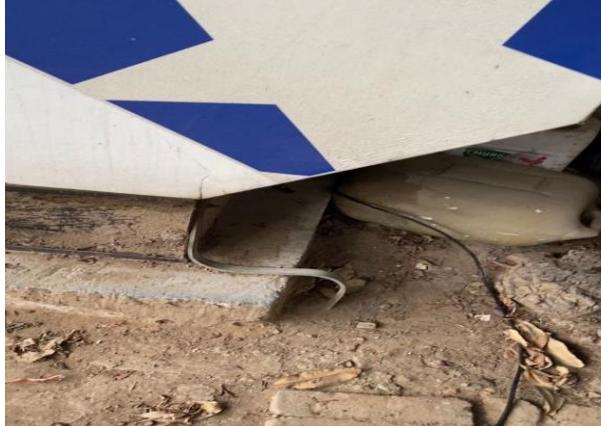
DG 160 kVA	It is unknown which earth pit is connected with DG Body	Identification Required

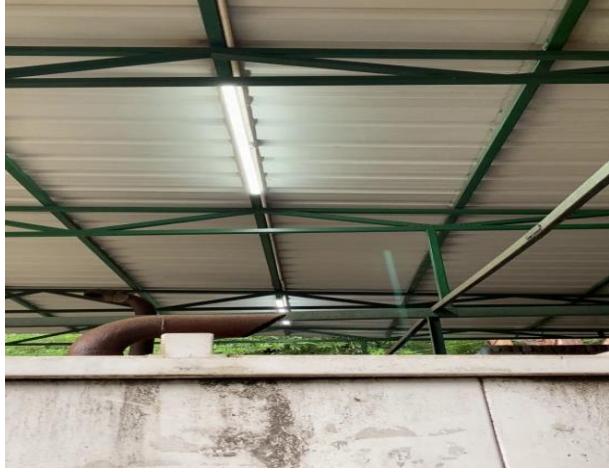
DG Yard	DG Yard has only two tube lights. Low lux level.	Need more lights for safety & working.

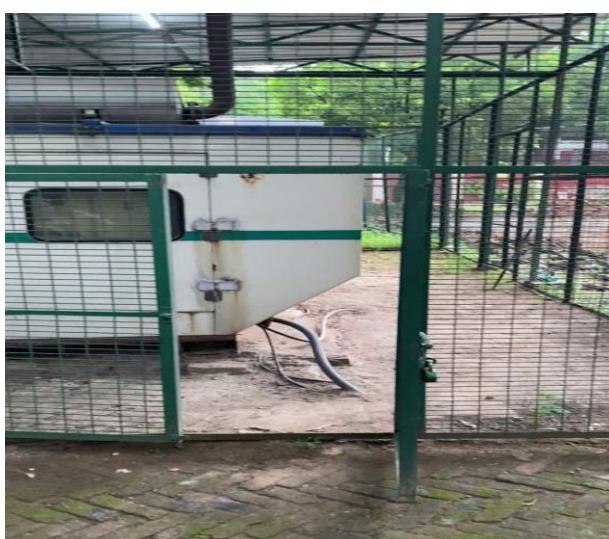
DG Yard	Low Height entrance at DG Yard. No key near entrance	Need bigger height gate for easy approach. Panel key must be near the gate.

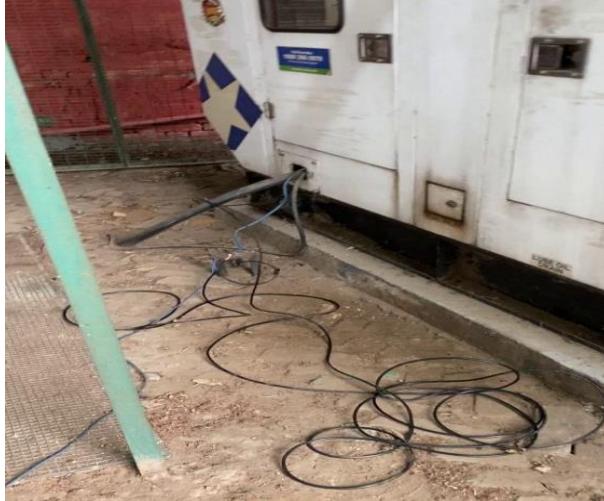
DG 160 kVA	Neutral Earthing Wire cables are kept open and connected to different areas	If required keep the wires in conduit or trench & it is recommended to connect only DG neutral with earthing.

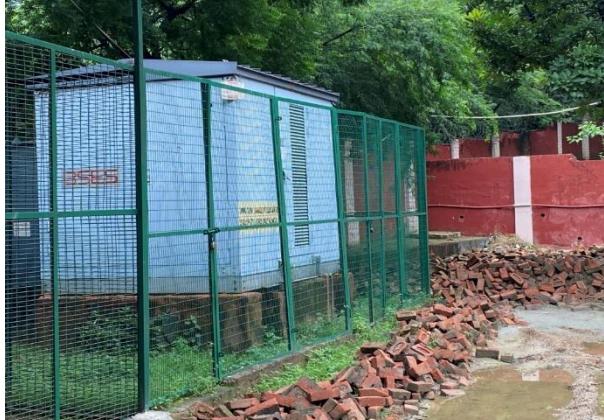
TR Switch Yard	No Danger sign board, sand buckets or fire extinguisher kept near TR Yard.	All required.

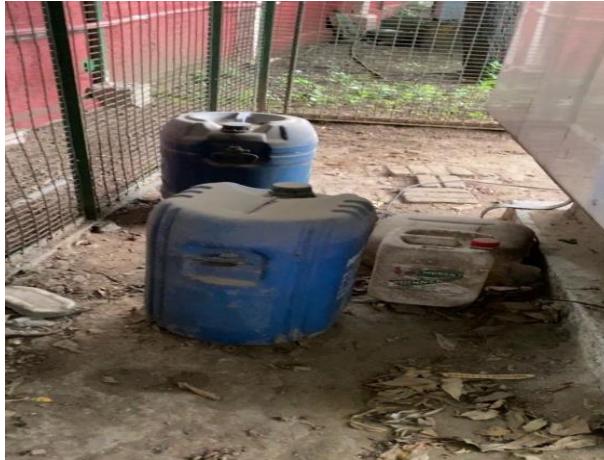
DG 160 kVA	Obstruction near 160 kVA DG	Remove unwanted items.

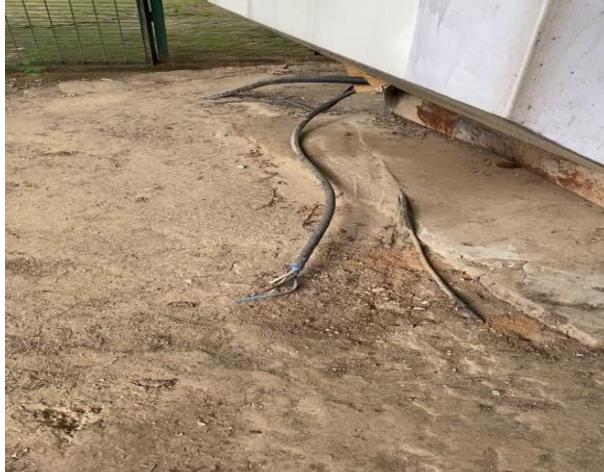
DG 125 kVA	Open wire near DG 125 kVA.	Attention required.

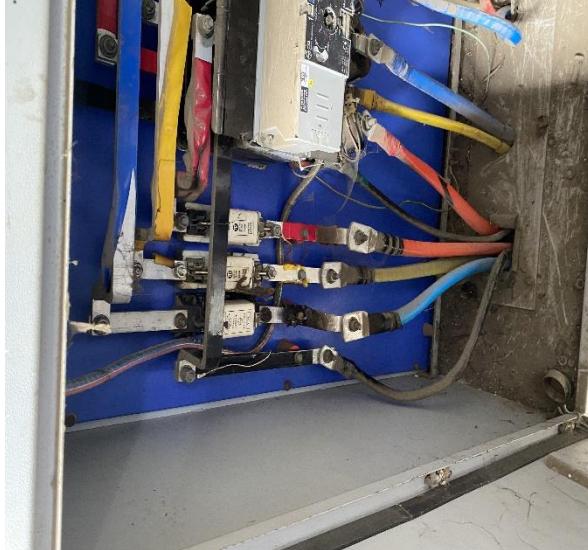
160 kVA DG Cum AMF Manual Panel	B Phase connection burnt. Insulation melted due to heat, Lizard	Need proper ventilation and cleaning.

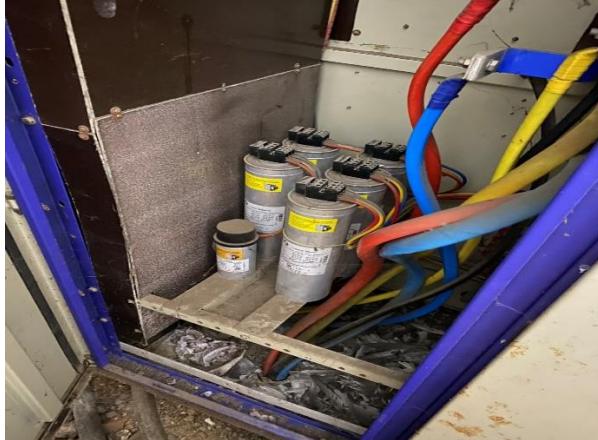
Hostel+JDVC Panel	Capacitor Panel Dusty	Cleaning required.

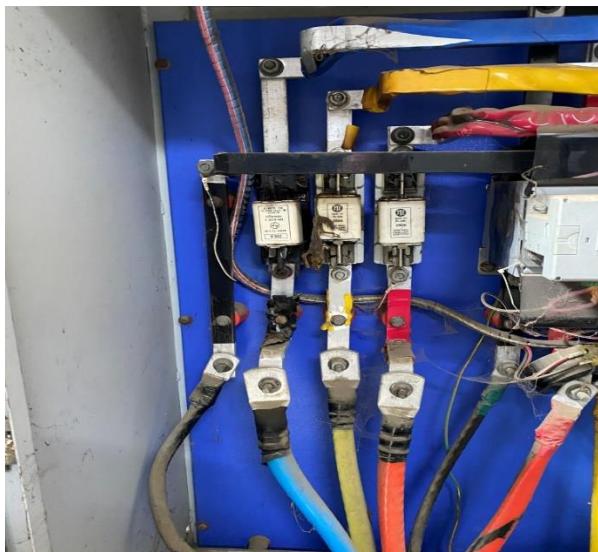
160 kVA DG Cum AMF Manual Panel	Dusty Panel	Need regular maintenance & cleaning.

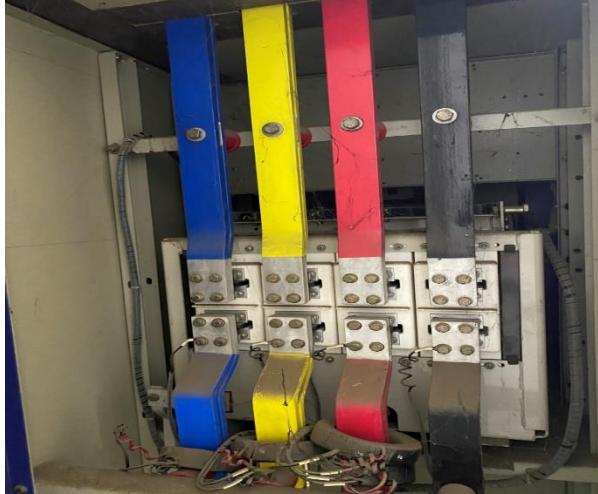
Hostel+JDVC Panel	Dusty Panels	Need regular maintenance & cleaning.

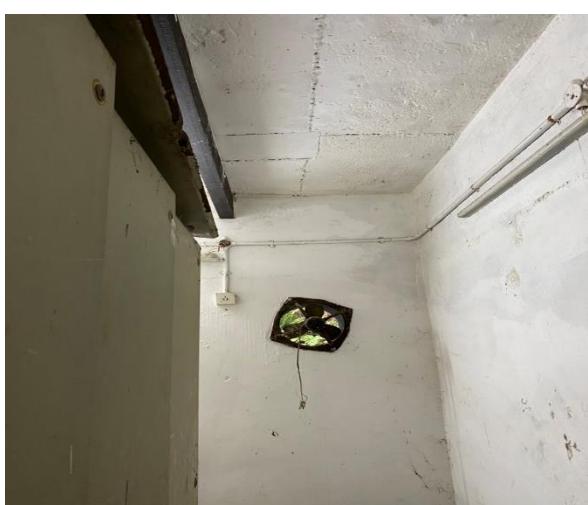
Hostel+JDVC Panel	No exhaust Fan working	Repair for proper ventilation.

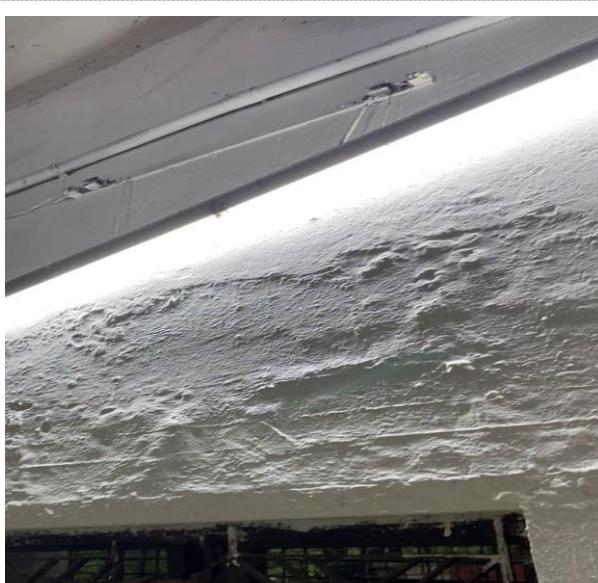
Hostel+JDVC Panel	Hanging Lights & wires	Proper hanging of lights and open wires in conduit.

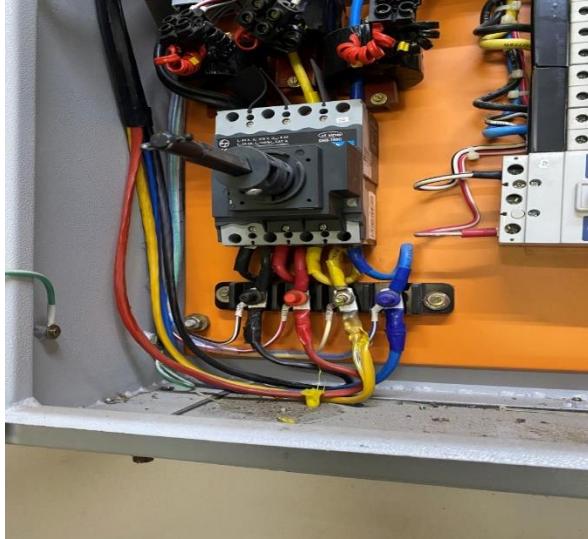
Hostel Panel GF	Y Phase Heat	Heating may be because of unbalance load or loose connection.

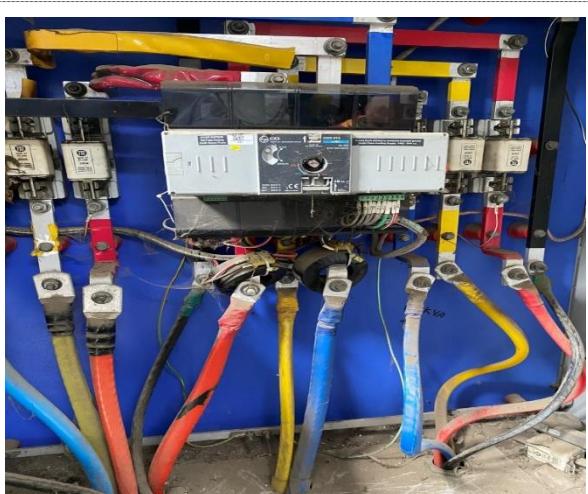
Hostel+JDVC Panel	Cobwebs	Need regular maintenance & cleaning

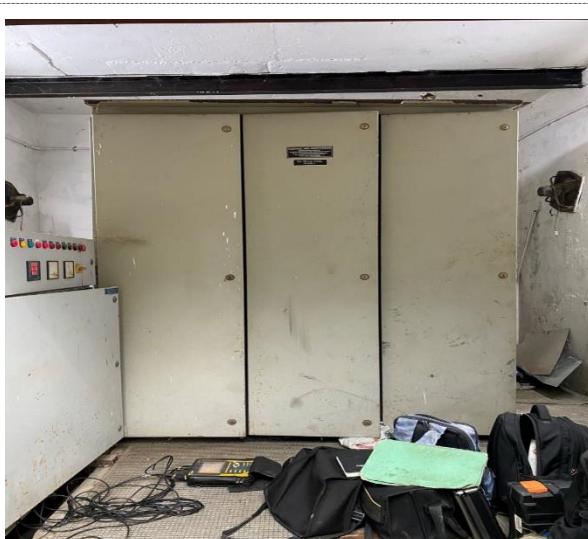
Hostel+JDVC Panel	No nomenclature, SLD, danger sign board, panel key, authorised person list with no.	All required

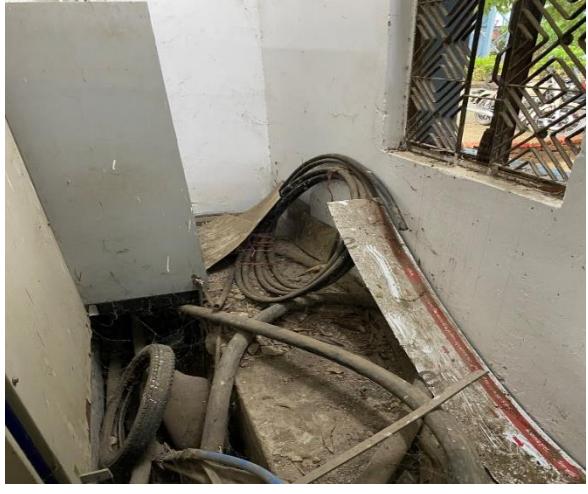
Hostel+JDVC Panel	No rubber mats	Install rubber mats

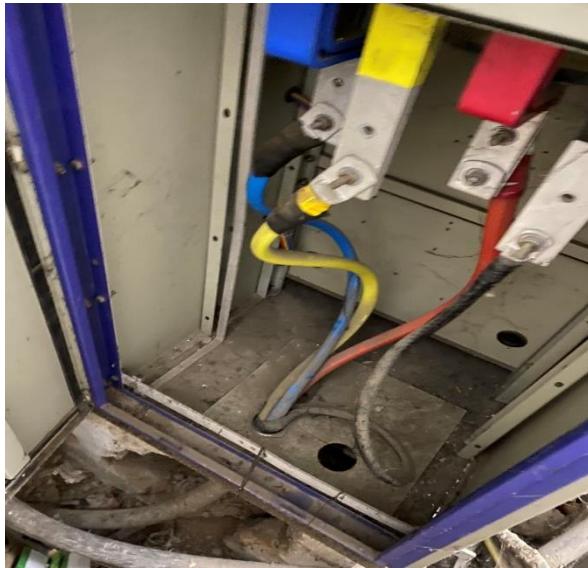
Hostel+JDVC Panel	Open holes for cable	Close

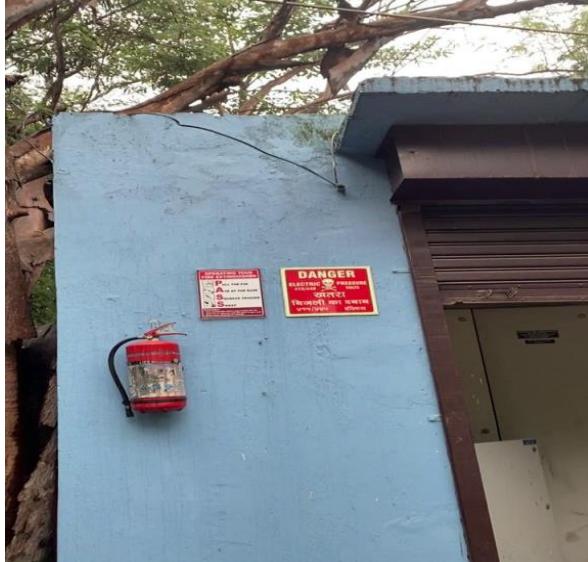
Hostel+JDVC Panel	Open wires outside panel room	Trench required

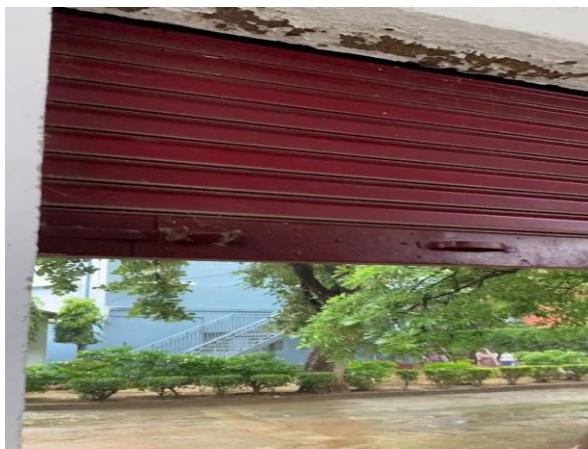
Hostel+JDVC Panel	Shutter always open and not earthed	Need proper gate with earthing

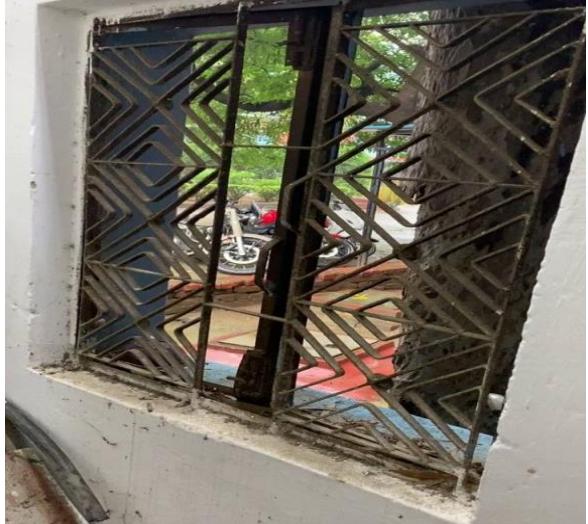
Hostel+JDVC Panel	Open window	Window need to be closed to avoid dust

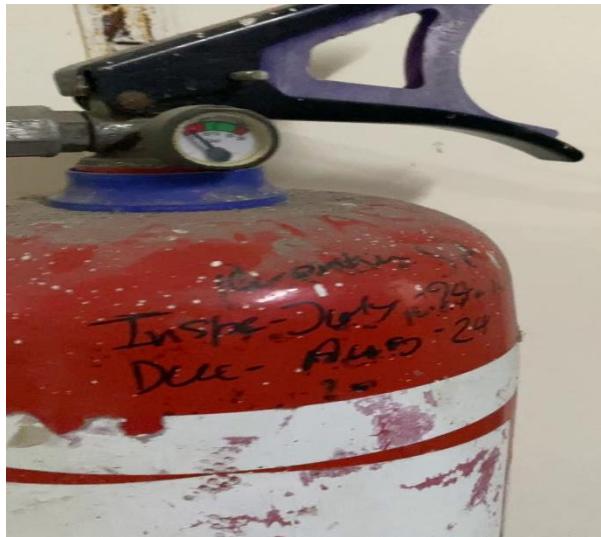
Admin Main Panel	Expired Extinguisher	Fire Recharge

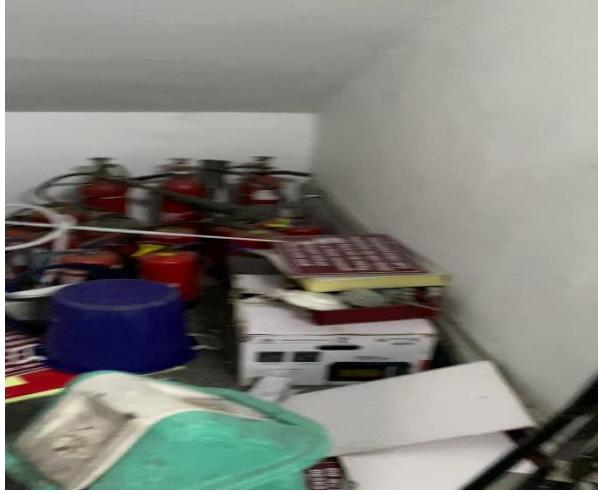
Admin Main Panel	Unwanted Material	Remove

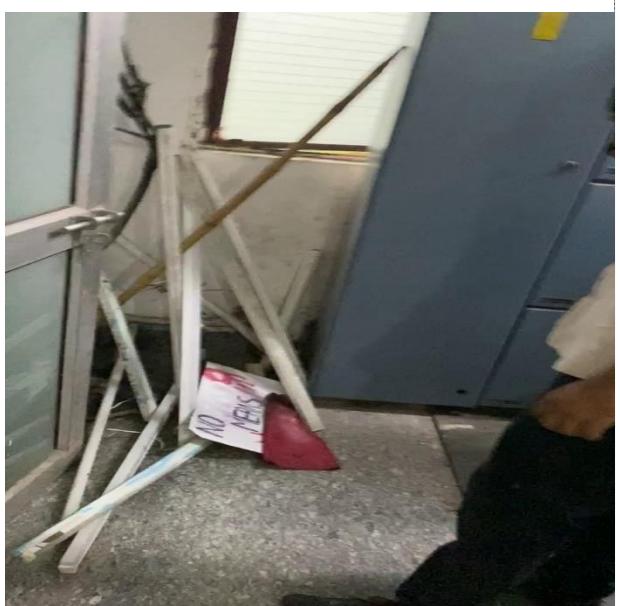
Admin Main Panel	Obstruction at Main entrance & Gate always open	Remove unwanted material & close gate when not required.

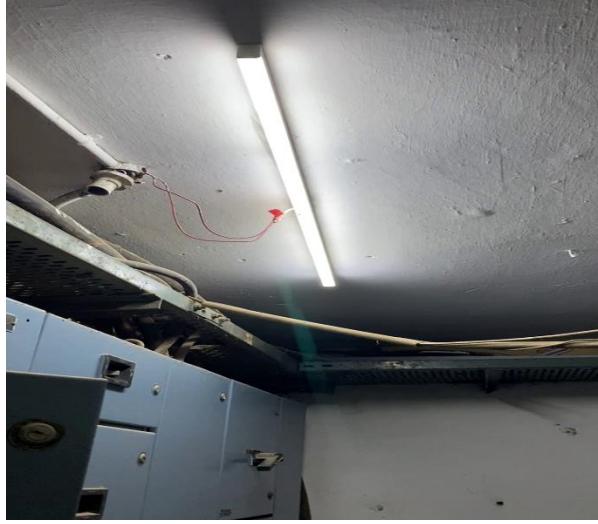
Admin Main Panel	Open cable	Keep it in conduit

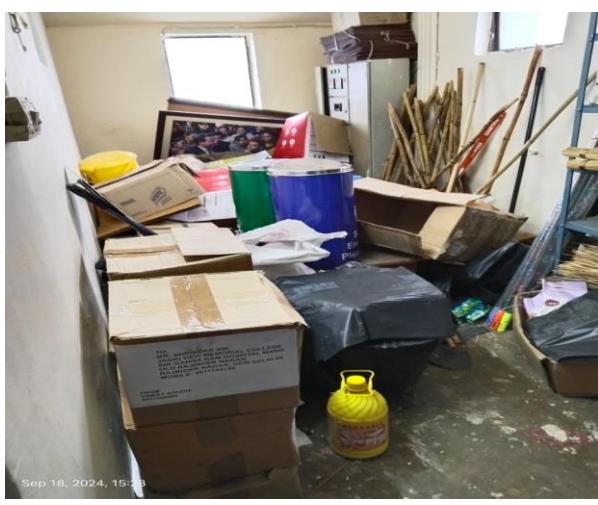
Admin 3rd Floor Panel	Unwanted Material	Remove for free movement

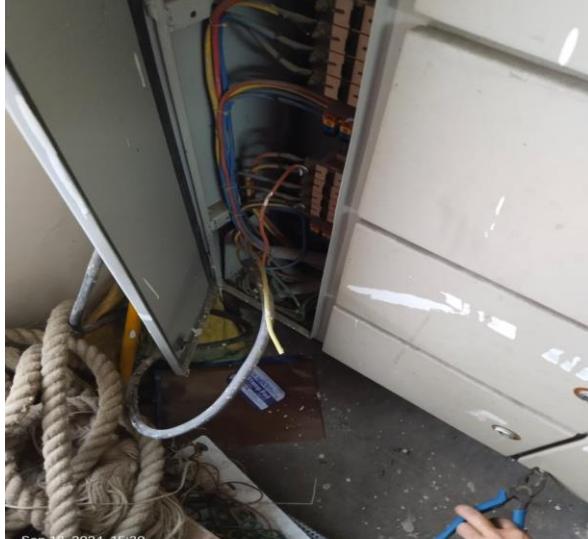
Admin 3 rd Floor Panel	Wire is being openly joined inside the panel.	Need proper connection
