ANNEXTURE (A)

THERMAL IMAGING FUNDAMENTALS AND METHODOLOGY

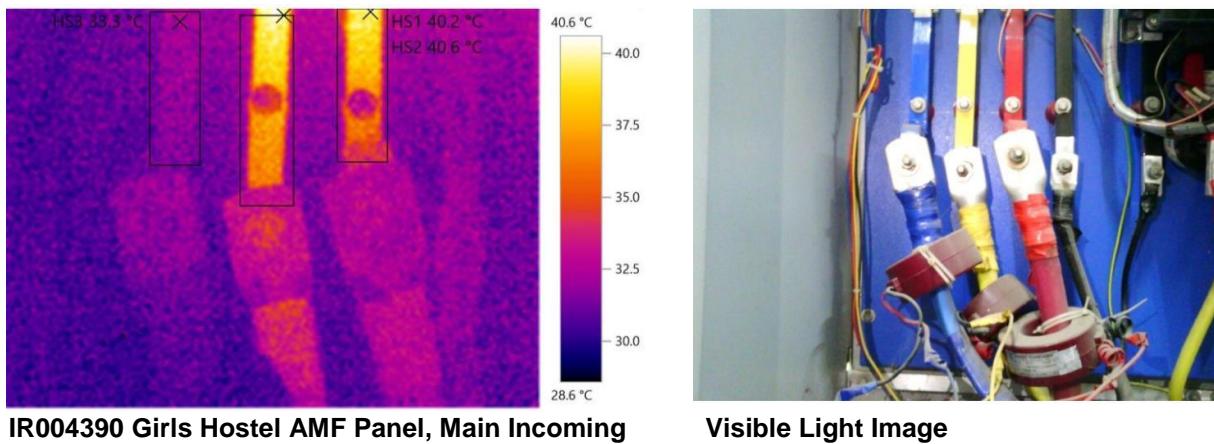
<https://www.atlanticleak.com/wp-content/uploads/2019/08/Standard-for-Infrared-Inspection-of-Electrical-systems-and-Rotating-Equipment.pdf>.

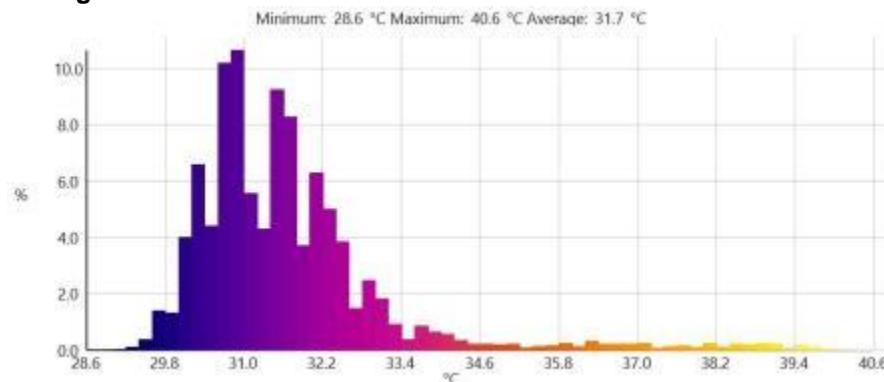
Analysis and Recommended Action	Observation: In the above thermo-gram the temperature difference between HS1 and HS3 (ΔT) is 6.9°C and HS2 and HS3 is 7.3°C. The thermo-gram is classified under Caution . Recommendation: The R and Y phase is experiencing heating due to the maximum load. It is recommended to balance the load across all phases.
----------------------------------------	--------------------------------------------------------------------------------------------------------------------------------------------------------------------------------------------------------------------------------------------------------------------------------------------------------------------------------------------------------------

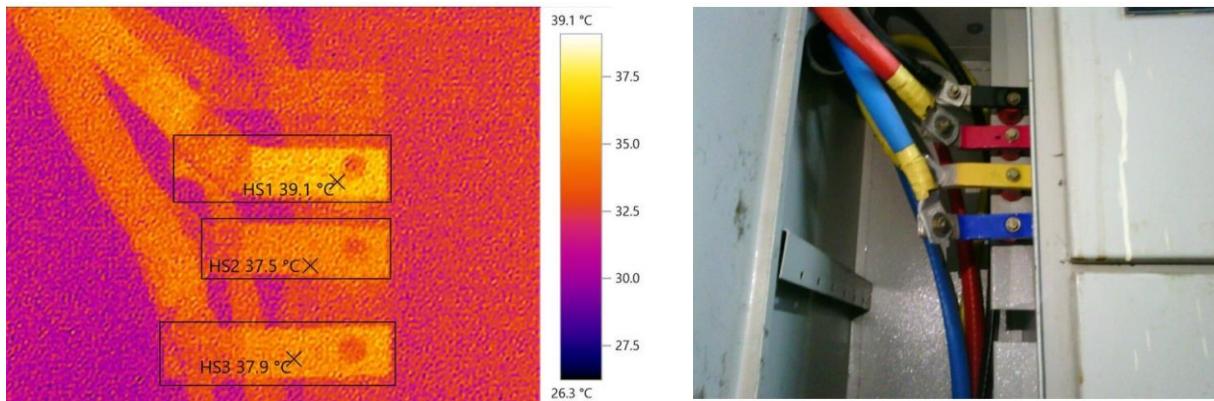
SR004388 JDVC Main Panel, Main Incoming

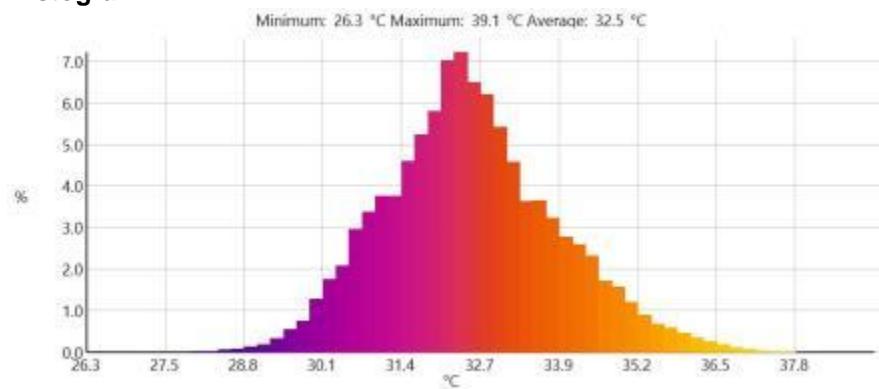
Analysis and Recommended Action	Observation: In the above thermo-gram the temperature difference between HS1 and HS2 (ΔT) is 1.6°C and HS2 and HS3 is 0.4°C. The thermo-gram is classified under Normal .
----------------------------------------	---------------------------------------------------------------------------------------------------------------------------------------------------------------------------------------------------

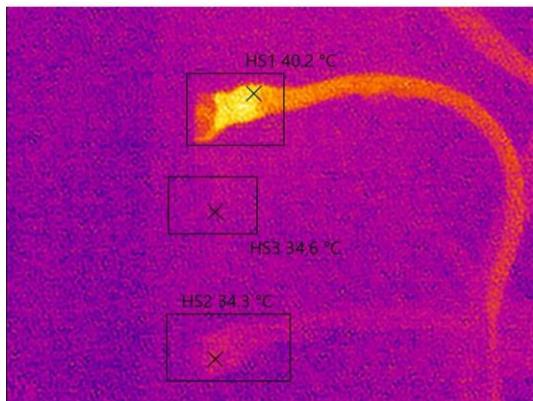
SR004389 JDVC Main Panel, First Floor outgoing

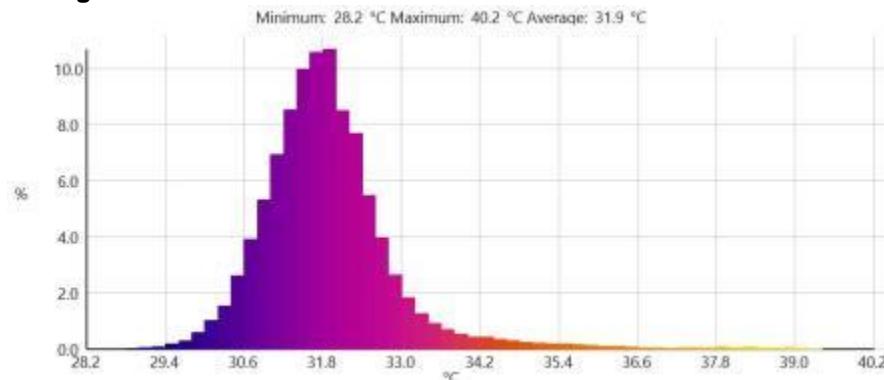
Analysis and Recommended Action	<p>Observation: In the above thermo-gram the temperature difference between HS1 and HS2 (ΔT) is 5.9°C and HS2 and HS3 is 0.3°C. The thermo-gram is classified under Caution.</p> <p>Recommendation: The R phase is experiencing heating due to the maximum load. It is recommended to balance the load across all phases.</p>
----------------------------------------	-----------------------------------------------------------------------------------------------------------------------------------------------------------------------------------------------------------------------------------------------------------------------------------------------------------------------------------------------------------------------

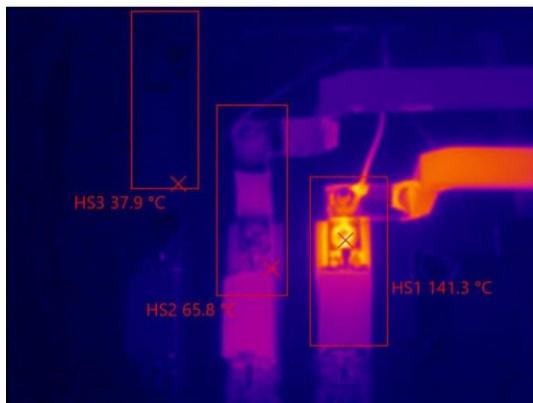
SR004391 Girls Hostel AMF Panel, Fuse outlet

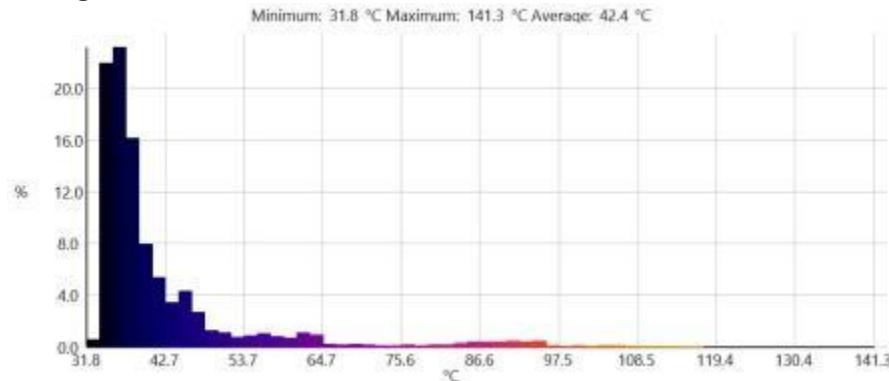
Analysis and Recommended Action	<p>Observation: In the above thermo-gram the temperature difference between HS1 and HS3 (ΔT) is 103.4°C and HS2 and HS3 is 27.9°C. The thermo-gram is classified under Alarming.</p> <p>Recommendation: The R phase is experiencing heating due to the maximum load. It is recommended to balance the load across all phases and retighten the connection of R phase.</p>
----------------------------------------	-------------------------------------------------------------------------------------------------------------------------------------------------------------------------------------------------------------------------------------------------------------------------------------------------------------------------------------------------------------------------------------------------------------------

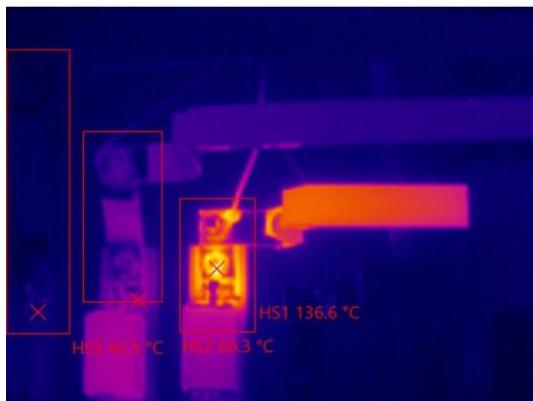
SR004392 Girls Hostel AMF Panel, Fuse outlet

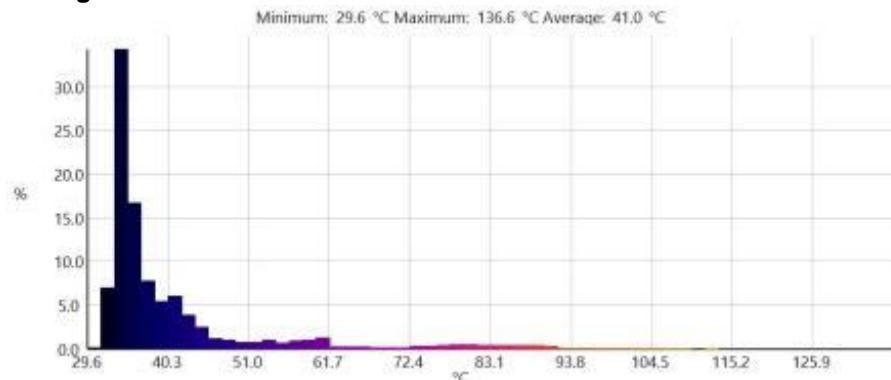
Analysis and Recommended Action	<p>Observation: In the above thermo-gram the temperature difference between HS1 and HS3 (ΔT) is 94.1°C and HS2 and HS3 is 17.8°C. The thermo-gram is classified under Alarming.</p> <p>Recommendation: The R phase is experiencing heating due to the maximum load. It is recommended to balance the load across all phases. and retighten the connection of R phase.</p>
----------------------------------------	-------------------------------------------------------------------------------------------------------------------------------------------------------------------------------------------------------------------------------------------------------------------------------------------------------------------------------------------------------------------------------------------------------------------

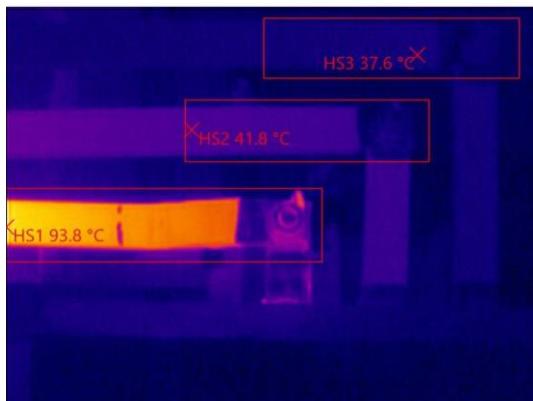
SR004393 Girls Hostel AMF Panel, Change Over
MCCB Inlet

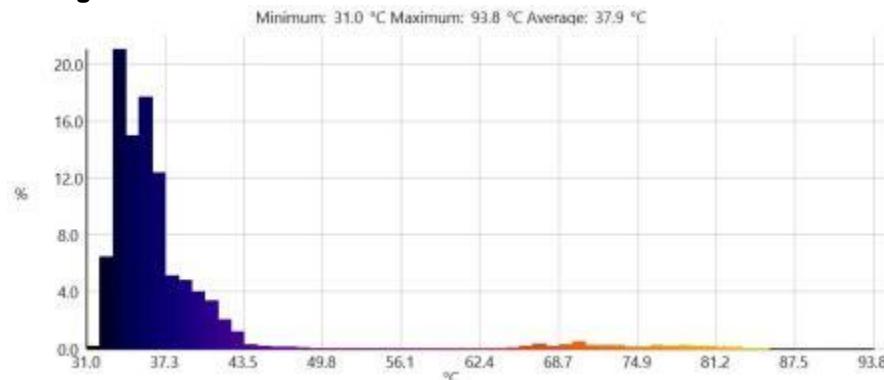
Analysis and Recommended Action	<p>Observation: In the above thermo-gram the temperature difference between HS1 and HS3 (ΔT) is 56.2°C and HS2 and HS3 is 4.2°C. The thermo-gram is classified under Alarming.</p> <p>Recommendation: The R phase is experiencing heating due to the maximum load. It is recommended to balance the load across all phases. and retighten the connection of R phase.</p>
----------------------------------------	----------------------------------------------------------------------------------------------------------------------------------------------------------------------------------------------------------------------------------------------------------------------------------------------------------------------------------------------------------------------------------------------------

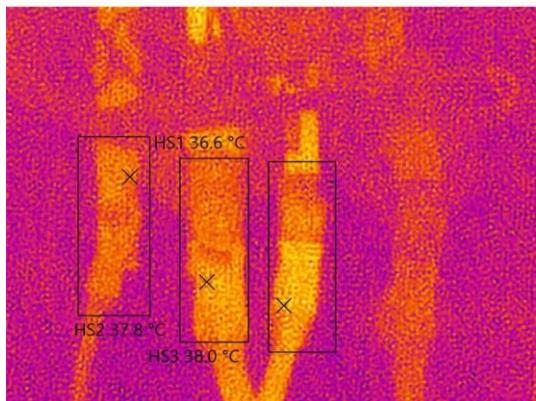
SR004394 Girls Hostel AMF Panel, Change over
MCCB Outlet

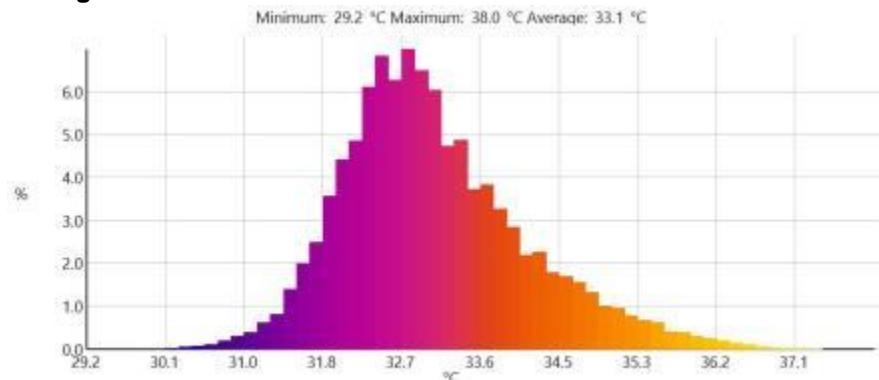
Analysis and Recommended Action	Observation: In the above thermo-gram the temperature difference between HS1 and HS2 (ΔT) is 1.2°C and HS1 and HS3 is 1.4°C. The thermo-gram is classified under Normal .
----------------------------------------	--------------------------------------------------------------------------------------------------------------------------------------------------------------------------------------------

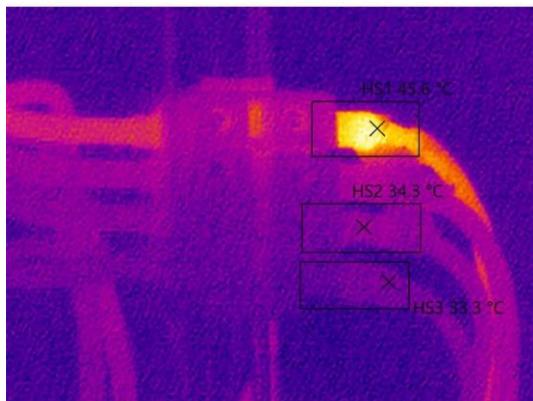
SR004395 Girls Hostel AMF Panel, VIth Floor outgoing

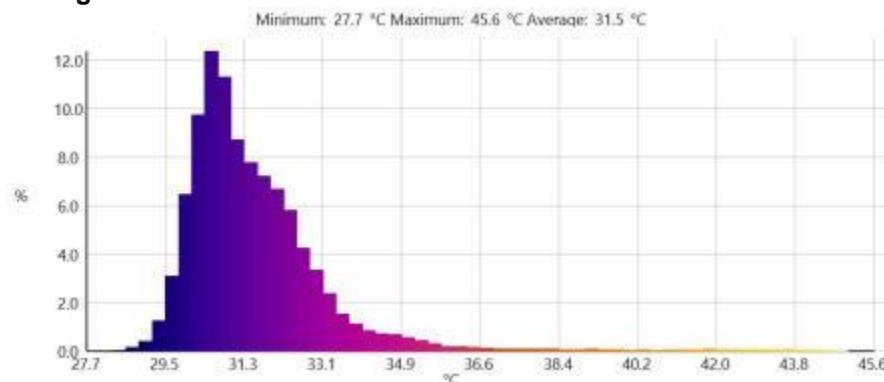
Analysis and Recommended Action

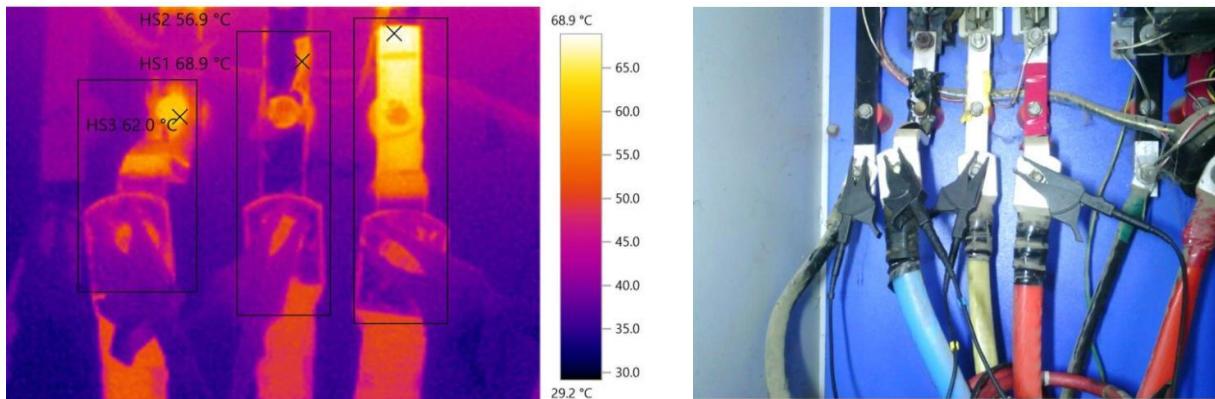
SR004541 DG Change over Panel, Main Incoming from Transformer

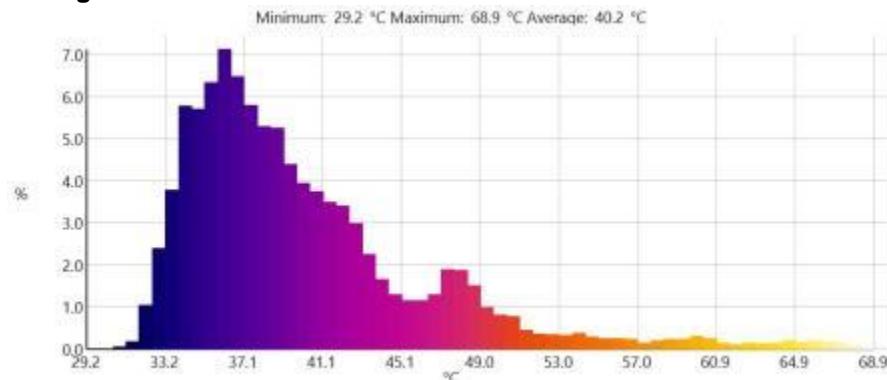
Analysis and Recommended Action	<p>Observation: In the above thermo-gram the temperature difference between HS1 and HS2 (ΔT) is 12.0°C and HS2 and HS3 is 5.1°C. The thermo-gram is classified under Caution.</p> <p>Recommendation: The R and B phase is experiencing heating due to the maximum load. It is recommended to balance the load across all phase and retighten the connection of R and B phase.</p>
----------------------------------------	---------------------------------------------------------------------------------------------------------------------------------------------------------------------------------------------------------------------------------------------------------------------------------------------------------------------------------------------------------------------------------------------------------------------------

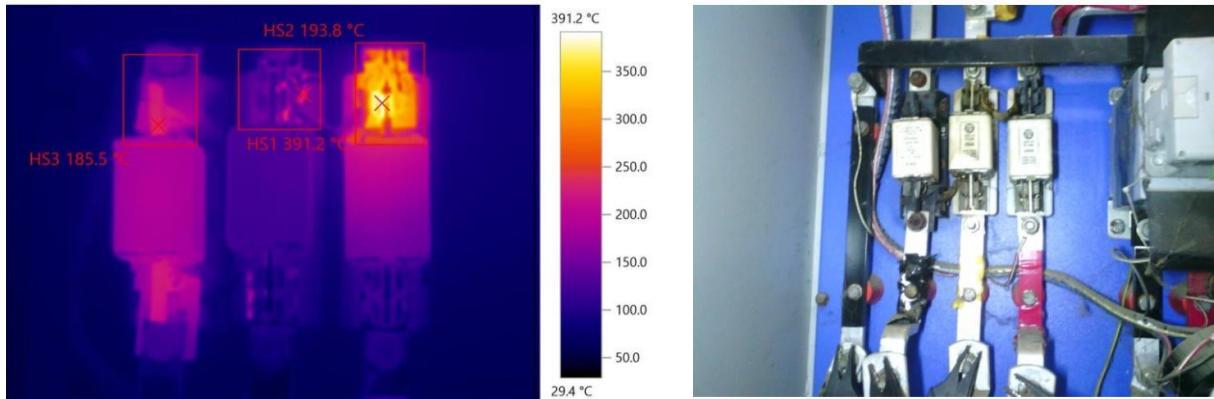
SR004542 DG Change over Panel, Fuse Inlet

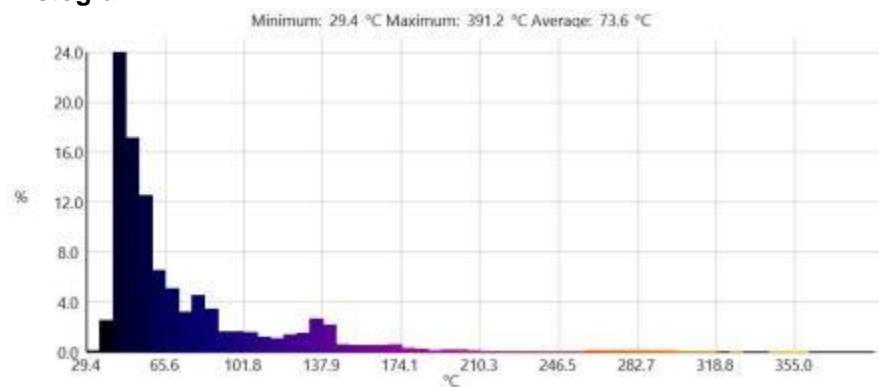
Analysis and Recommended Action	<p>Observation: In the above thermo-gram the temperature difference between HS1 and HS3 (ΔT) is 205.7°C and HS2 and HS3 is 8.3°C. The thermo-gram is classified under Alarming.</p> <p>Recommendation: The R and B phase is experiencing heating due to the maximum load. It is recommended to balance the load across all phase and retighten the connection of R and B phase.</p>
----------------------------------------	-----------------------------------------------------------------------------------------------------------------------------------------------------------------------------------------------------------------------------------------------------------------------------------------------------------------------------------------------------------------------------------------------------------------------------

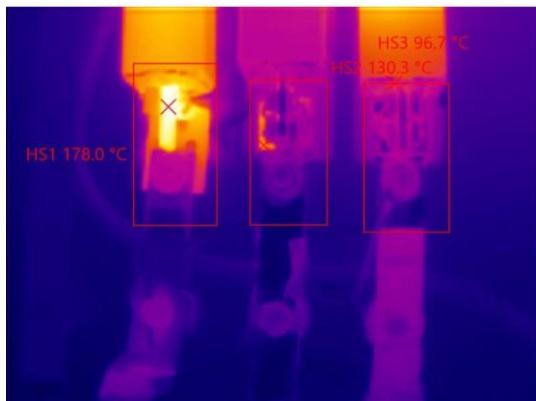
SR004544 DG Change over Panel, Fuse Outlet

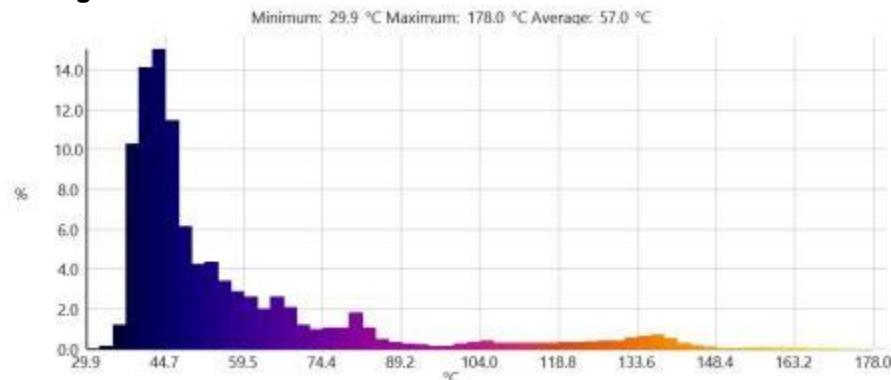
Analysis and Recommended Action	<p>Observation: In the above thermo-gram the temperature difference between HS1 and HS3 (ΔT) is 81.3°C and HS2 and HS3 is 33.6°C. The thermo-gram is classified under Alarming.</p> <p>Recommendation: The R and B phase is experiencing heating due to the maximum load. It is recommended to balance the load across all phases and retighten the connection of R and B phase.</p>
----------------------------------------	------------------------------------------------------------------------------------------------------------------------------------------------------------------------------------------------------------------------------------------------------------------------------------------------------------------------------------------------------------------------------------------------------------------------------

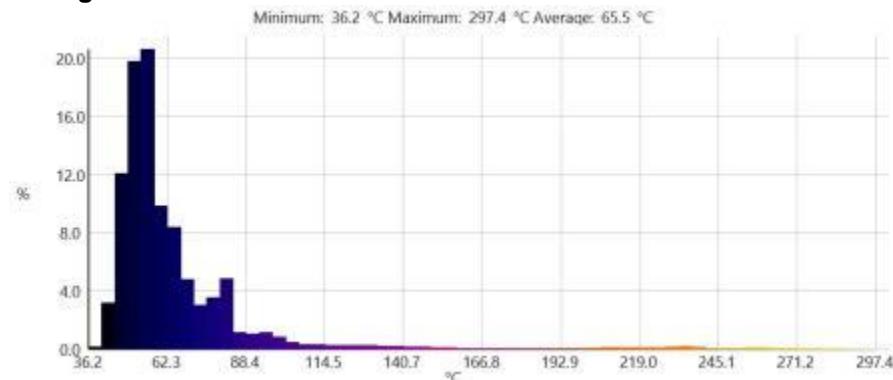
Analysis and Recommended Action	<p>Observation: In the above thermo-gram the temperature difference between HS1 and HS3 (ΔT) is 194.2°C and HS2 and HS3 is 120.3°C. The thermo-gram is classified under Alarming.</p> <p>Recommendation: The R and B phase is experiencing heating due to the maximum load. It is recommended to balance the load across all phases and retighten the connection of R and B phase.</p>
----------------------------------------	--------------------------------------------------------------------------------------------------------------------------------------------------------------------------------------------------------------------------------------------------------------------------------------------------------------------------------------------------------------------------------------------------------------------------------

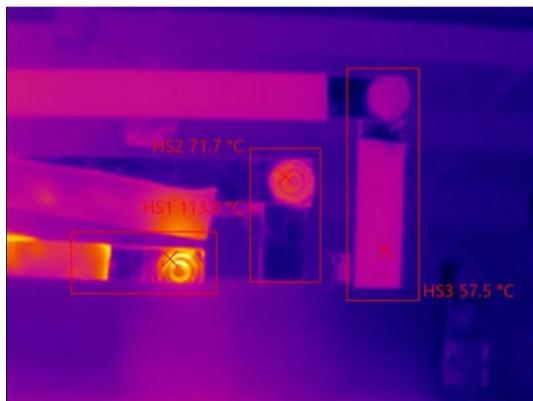
SR004547 DG Change over Panel, MCCB Change Over

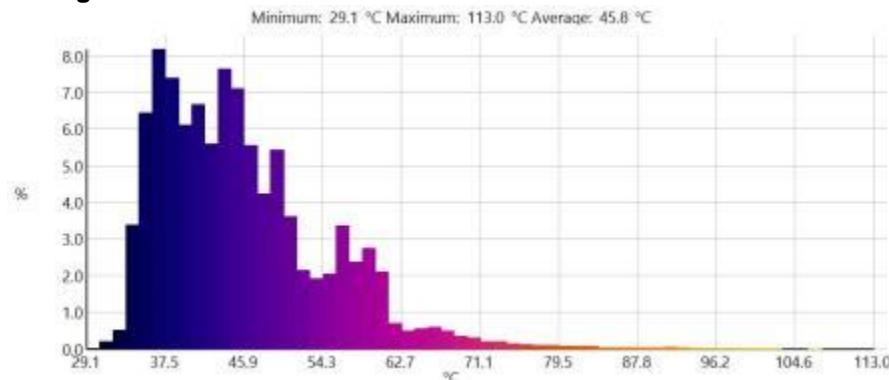
Analysis and Recommended Action	<p>Observation: In the above thermo-gram the temperature difference between HS1 and HS3 (ΔT) is 55.5°C and HS2 and HS3 is 14.2°C. The thermo-gram is classified under Alarming.</p> <p>Recommendation: The R phase is experiencing heating due to the maximum load. It is recommended to balance the load across all phases and retighten the connection of R phase.</p>
----------------------------------------	------------------------------------------------------------------------------------------------------------------------------------------------------------------------------------------------------------------------------------------------------------------------------------------------------------------------------------------------------------------------------------------------------------------

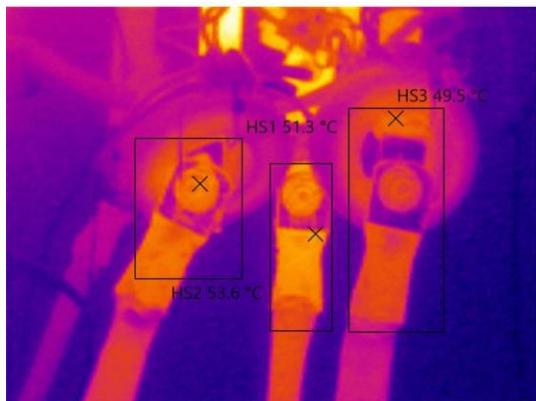
SR004549 DG Change over Panel, MCCB Change Over outgoing to Admin Main Panel

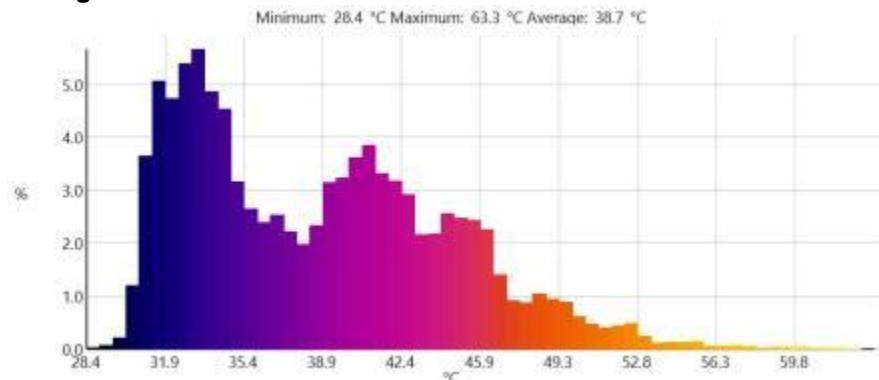
Analysis and Recommended Action	<p>Observation: In the above thermo-gram the temperature difference between HS1 and HS3 (ΔT) is 1.8°C and HS2 and HS3 is 4.1°C. The thermo-gram is classified under Caution.</p> <p>Recommendation: It is recommended to balance the load across all phases and retighten the connection of all phases.</p>
----------------------------------------	-----------------------------------------------------------------------------------------------------------------------------------------------------------------------------------------------------------------------------------------------------------------------------------------------------------------------------------------------------

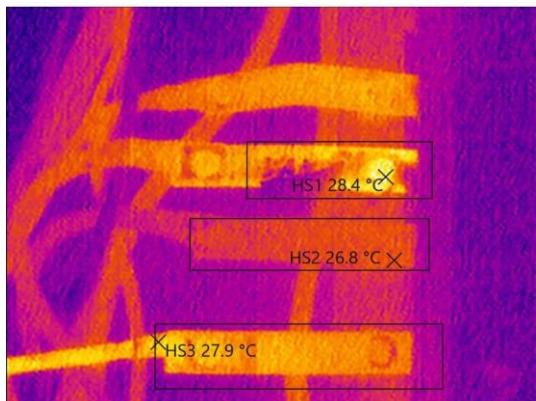
SR004550 Admin GF Sub Main Panel-3, Main Incoming

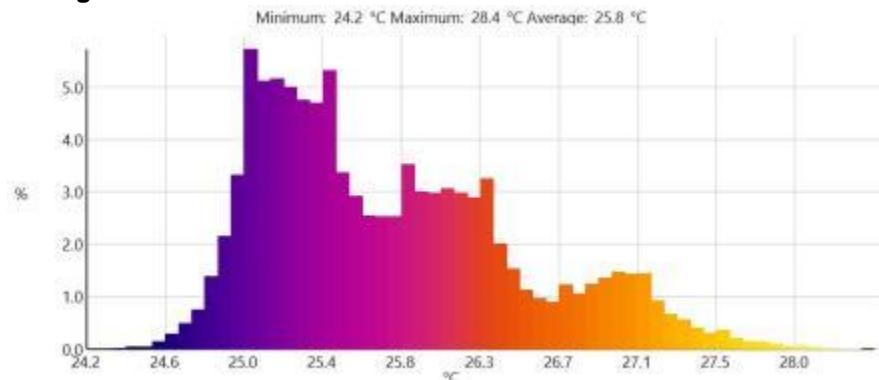
Analysis and Recommended Action	Observation: In the above thermo-gram the temperature difference between HS1 and HS2 (ΔT) is 1.6°C and HS2 and HS3 is 1.1°C. The thermo-gram is classified under Normal .
----------------------------------------	---------------------------------------------------------------------------------------------------------------------------------------------------------------------------------------------------

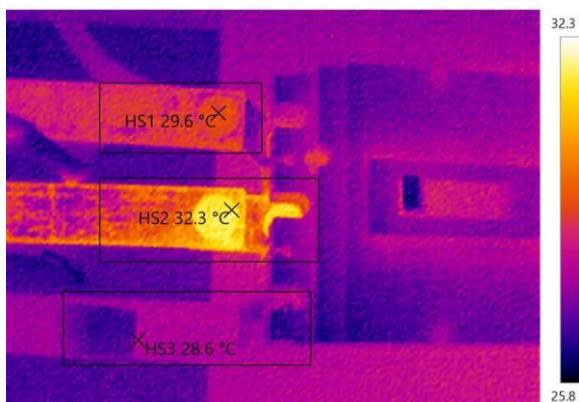
SR004551 Admin GF Sub Main Panel-3, Main Incoming MCB Inlet

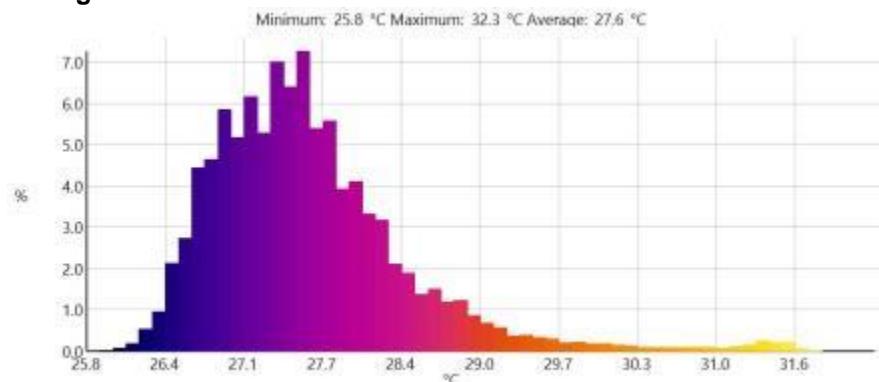
Analysis and Recommended Action

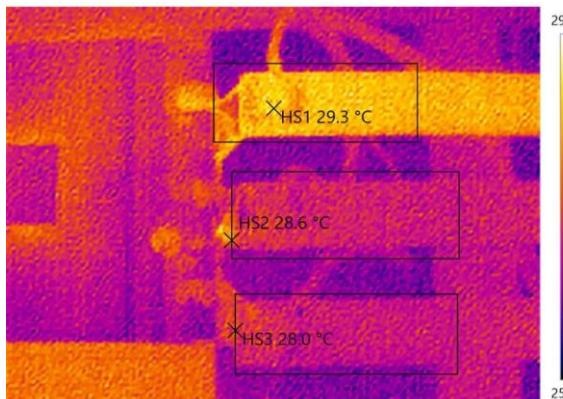
SR004552 Admin GF Sub Main Panel-3, Main Incoming MCB Outlet

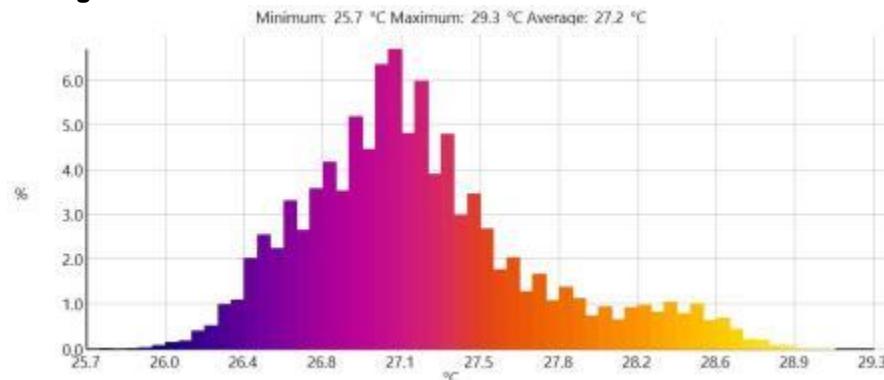
Analysis and Recommended Action	Observation: In the above thermo-gram the temperature difference between HS1 and HS3 (ΔT) is 1.3°C and HS2 and HS3 is 0.6°C. The thermo-gram is classified under Normal .
----------------------------------------	---------------------------------------------------------------------------------------------------------------------------------------------------------------------------------------------------

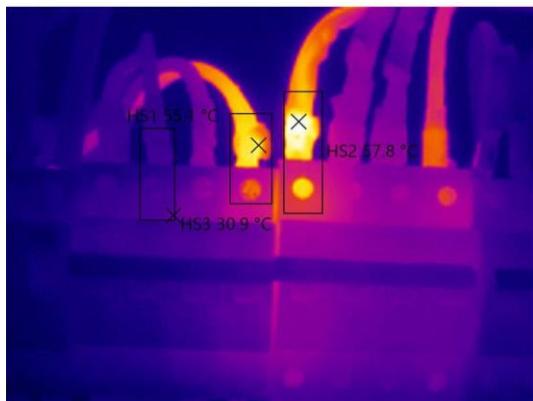
SR004553 Admin GF Sub Main Panel-3,
Distribution Panel MCB-2 and 3

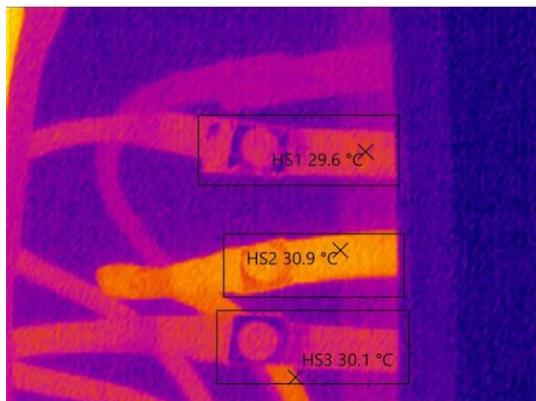
SR004554 Admin GF Sub Main Panel-4, Main Incoming

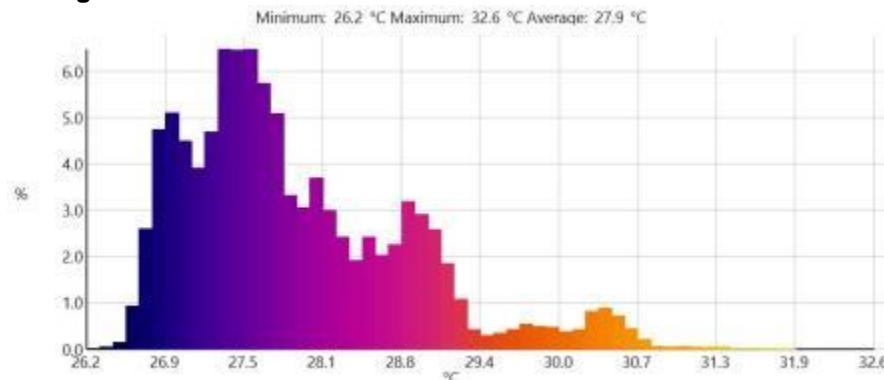
Analysis and Recommended Action	Observation: In the above thermo-gram the temperature difference between HS1 and HS2 (ΔT) is 1.3°C and HS1 and HS3 is 0.5°C. The thermo-gram is classified under Normal .
----------------------------------------	---------------------------------------------------------------------------------------------------------------------------------------------------------------------------------------------------

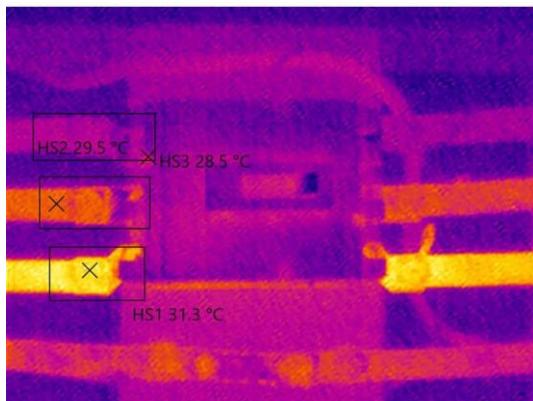
SR004555 Admin GF Sub Main Panel-4, Main Incoming MCB Inlet

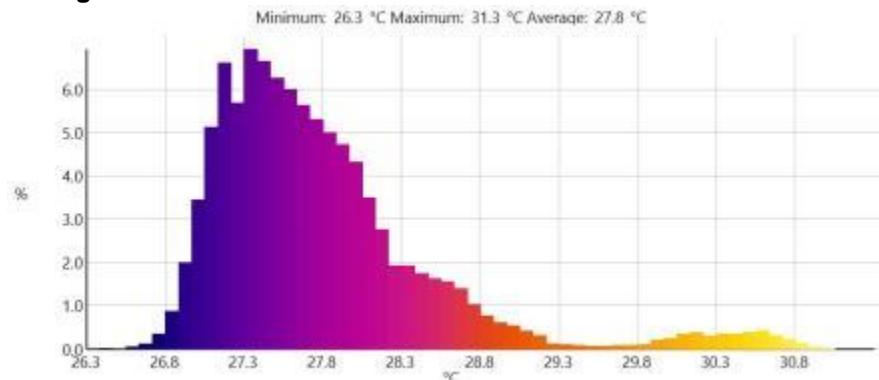
Analysis and Recommended Action

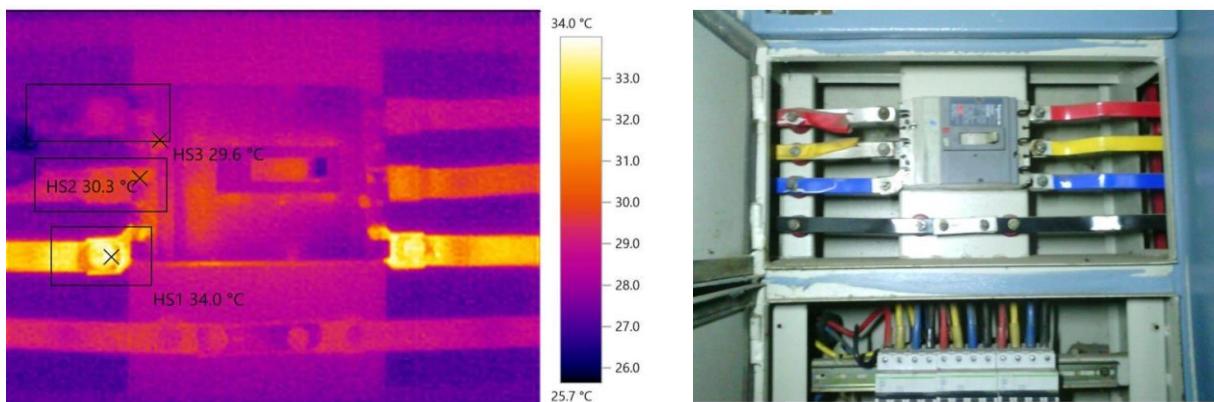
SR004556 Admin GF Sub Main Panel-4, Feeder-1F3
Auditorium MCB

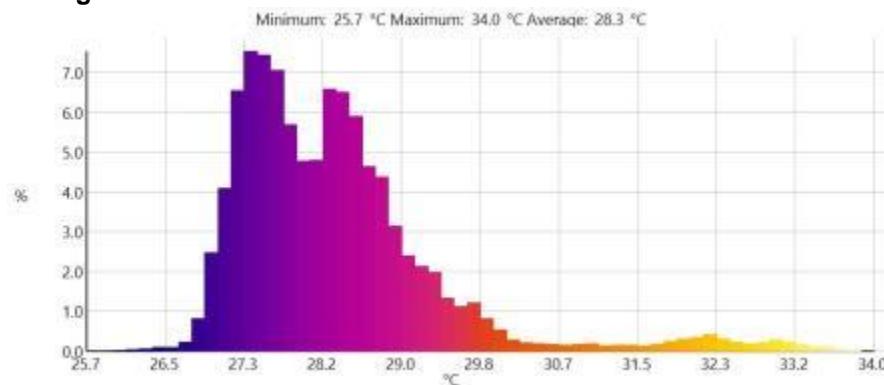
Analysis and Recommended Action	<p>Observation: In the above thermo-gram the temperature difference between HS1 and HS3 (ΔT) is 4.4°C and HS2 and HS3 is 0.7°C. The thermo-gram is classified under Caution.</p> <p>Recommendation: The B phase is experiencing heating due to the maximum load. It is recommended to balance the load across all phases and retighten the connection of B phase.</p>
----------------------------------------	---------------------------------------------------------------------------------------------------------------------------------------------------------------------------------------------------------------------------------------------------------------------------------------------------------------------------------------------------------------------------------------------------------------

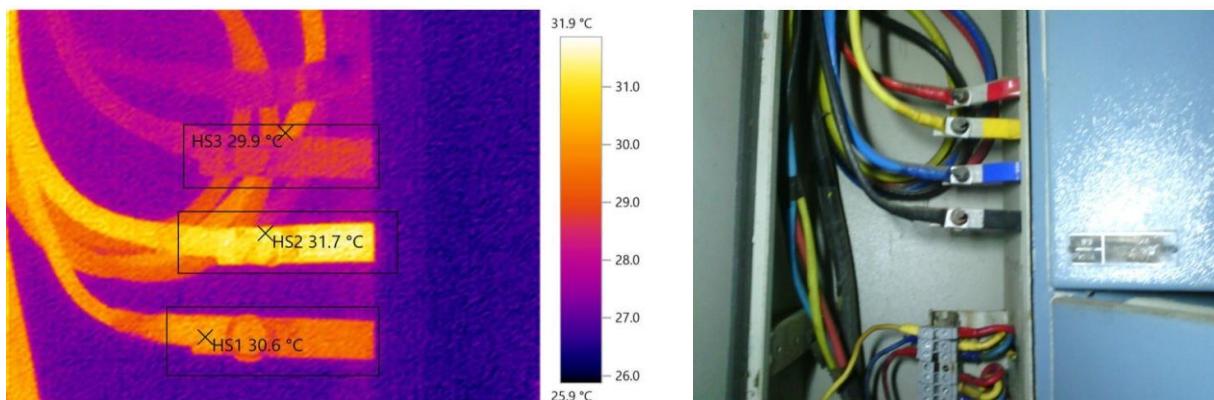
SR004557 Admin GF Sub Main Panel-4, Feeder-1F3
Auditorium Outgoing

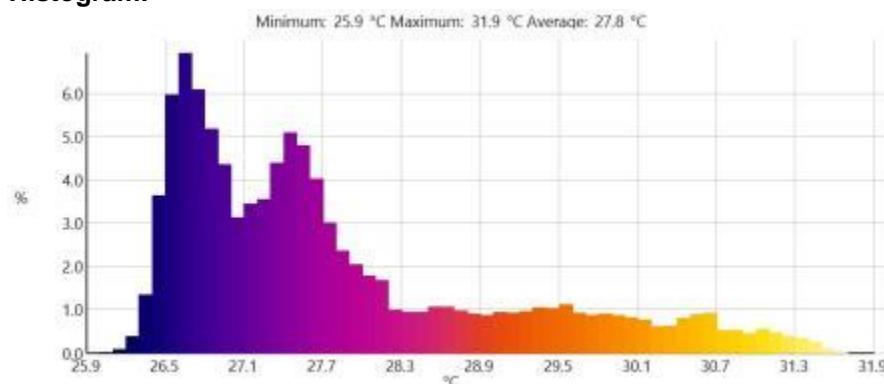
Analysis and Recommended Action	Observation: In the above thermo-gram the temperature difference between HS1 and HS3 (ΔT) is 0.7°C and HS2 and HS3 is 1.8°C. The thermo-gram is classified under Normal .
----------------------------------------	---------------------------------------------------------------------------------------------------------------------------------------------------------------------------------------------------

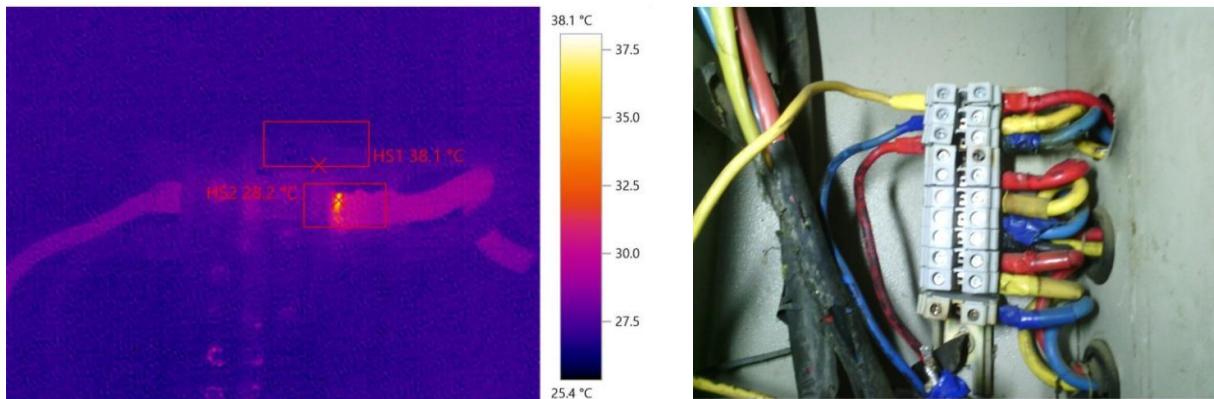
SR004558 Admin GF Sub Main Panel-4, Feeder-1F4
Distribution Panel

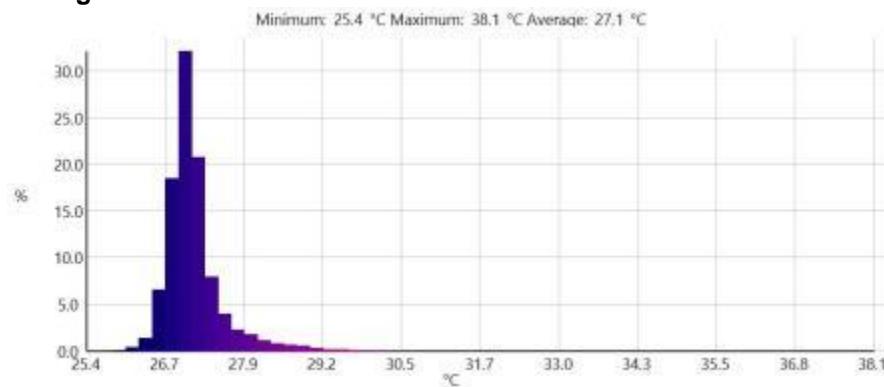
Analysis and Recommended Action	<p>Observation: In the above thermo-gram the temperature difference between HS1 and HS2 (ΔT) is 9.9°C. The thermo-gram is classified under Caution.</p> <p>Recommendation: Heating was observed on the R phase. It is recommended to retighten the connection of R phase. It is recommended to re-crimp the R phase.</p>
----------------------------------------	------------------------------------------------------------------------------------------------------------------------------------------------------------------------------------------------------------------------------------------------------------------------------------------------------------------------------------------------------------------

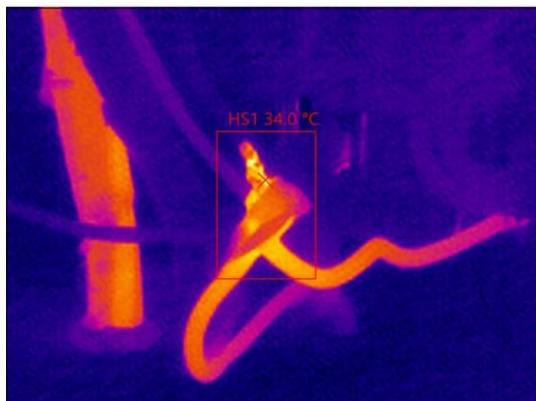
SR004559 Admin GF Sub Main Panel-4, Feeder-1F4
Distribution Panel

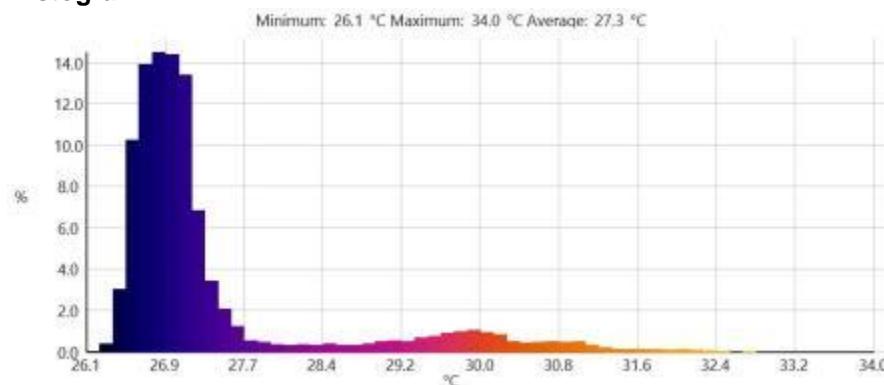
Analysis and Recommended Action	<p>Observation: In the above picture marking the running temperature is 34.0°C. The thermograph is classified under Caution.</p> <p>Recommendation: Heating was observed on the Neutral phase. It is recommended to retighten the connection of Neutral phase with thimble and also recommended to re-crimp the Neutral phase.</p>
----------------------------------------	---------------------------------------------------------------------------------------------------------------------------------------------------------------------------------------------------------------------------------------------------------------------------------------------------------------------------------------------------------

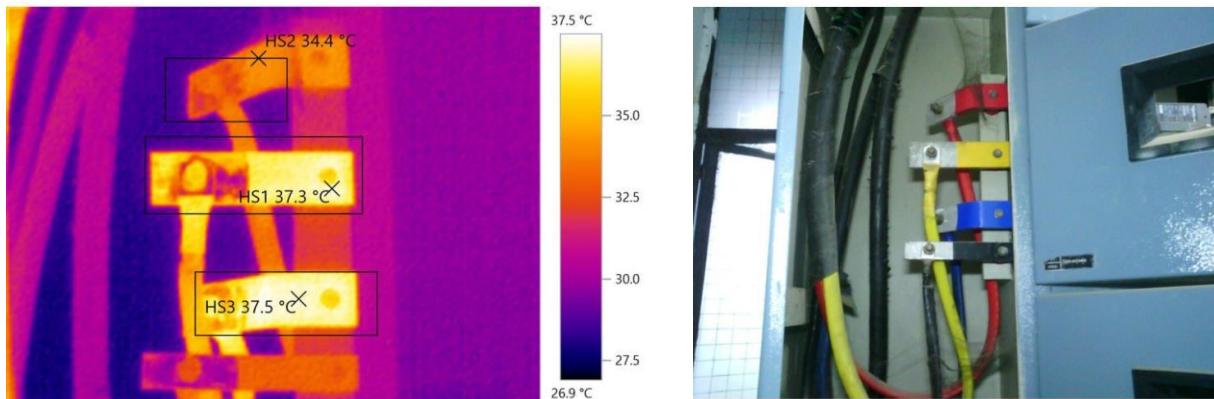
SR004560 Admin Building Main Panel, Main Incoming from DG Changeover Panel

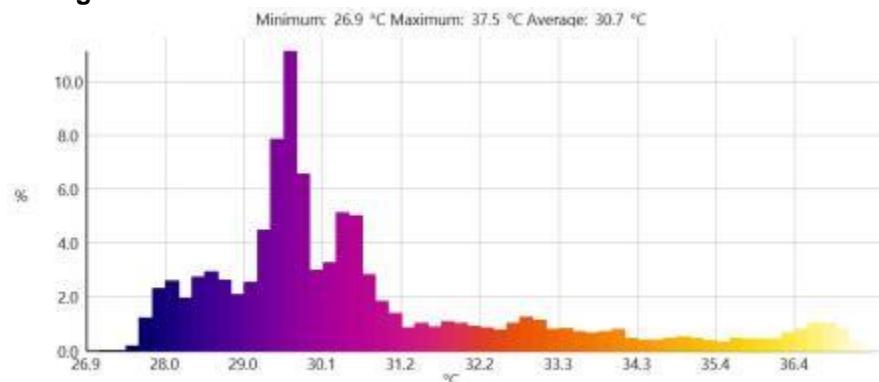
Analysis and Recommended Action	Observation: In the above picture marking the temperature difference between HS1 and HS2 (ΔT) is 2.9°C and HS2 and HS3 (ΔT) is 3.1°C. The thermograph is classified under Normal .
----------------------------------------	----------------------------------------------------------------------------------------------------------------------------------------------------------------------------------------------------------------------

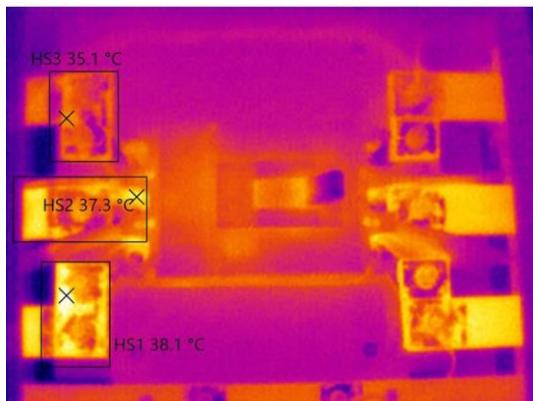
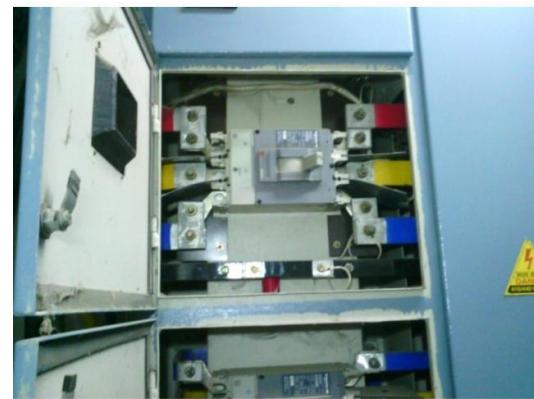
SR004561 Admin Building Main Panel, Feeder-1F1
Main Incoming MCCB

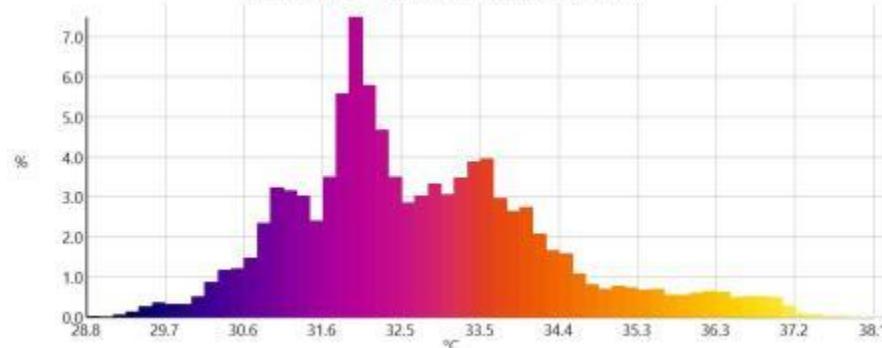
Analysis and Recommended Action

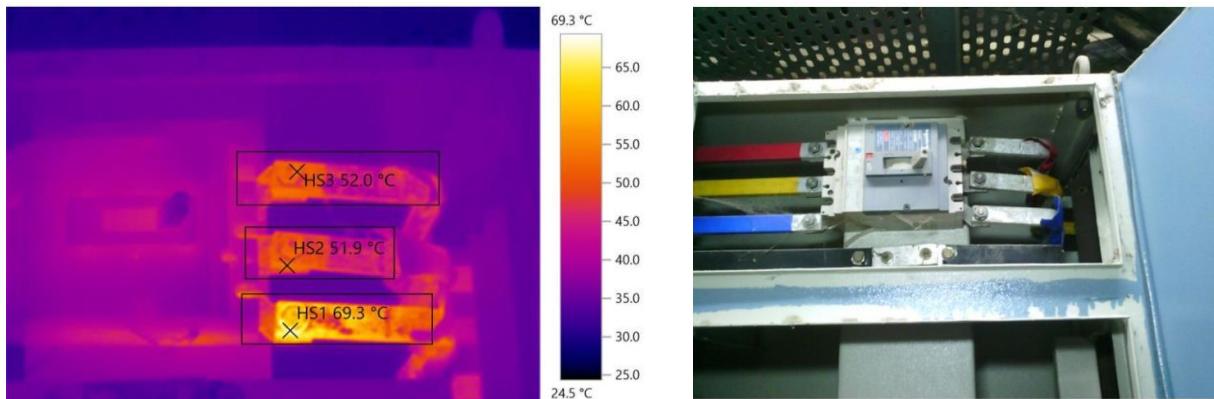
SR004562 Admin Building Main Panel, AMF Supply

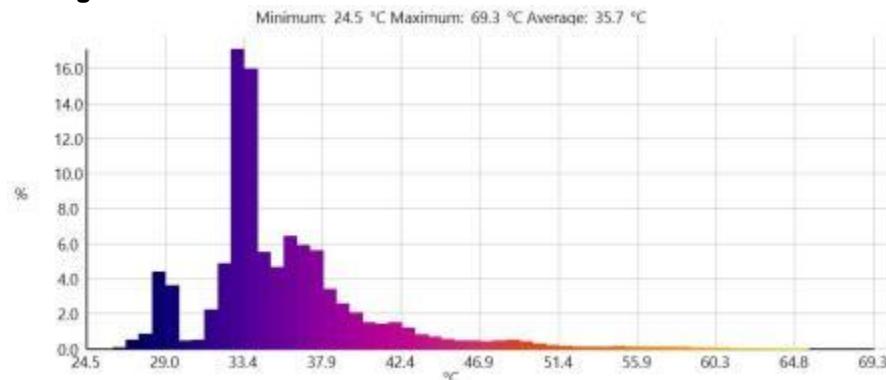
Analysis and Recommended Action	<p>Observation: In the above picture marking the temperature difference between HS1 and HS2 (ΔT) is 17.4°C and HS2 and HS3 (ΔT) is 0.1°C. The thermograph is classified under Alarming.</p> <p>Recommendation: The B phase is experiencing heating due to the maximum load. It is recommended to balance the load across all phases and retighten the connection of B phase.</p>
----------------------------------------	---------------------------------------------------------------------------------------------------------------------------------------------------------------------------------------------------------------------------------------------------------------------------------------------------------------------------------------------------------------------------------------------------------------------------------------------

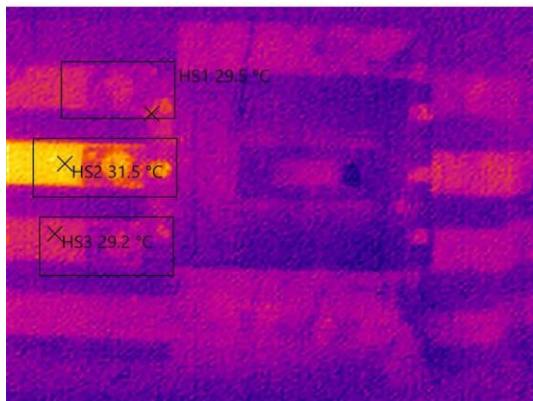
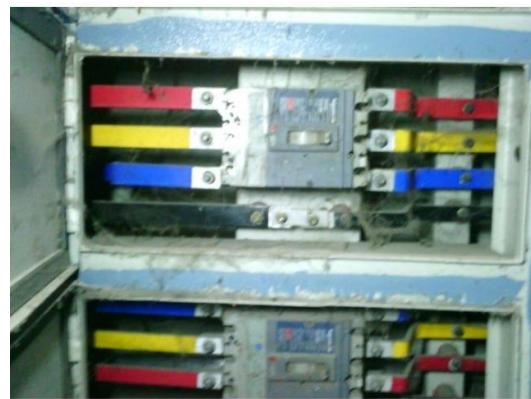
SR004563 Admin Building Main Panel, Feeder-2F6
Class Room

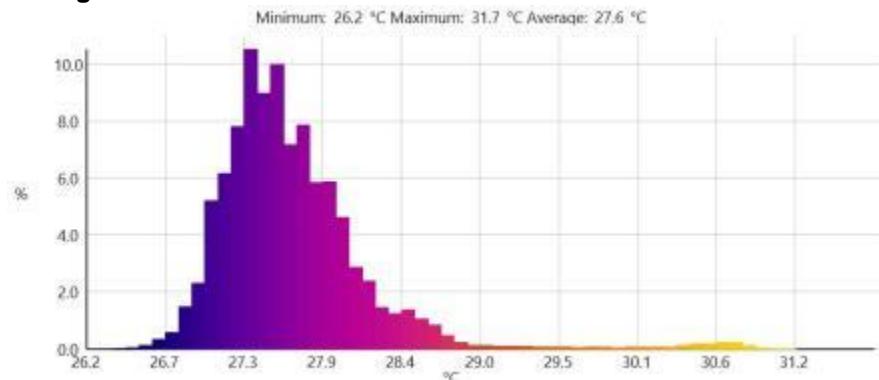
Analysis and Recommended Action	Observation: In the above picture marking the temperature difference between HS1 and HS3 (ΔT) is 0.3°C and HS2 and HS3 (ΔT) is 2.3°C. The thermograph is classified under Normal .
----------------------------------------	----------------------------------------------------------------------------------------------------------------------------------------------------------------------------------------------------------------------
