ANNEXTURE (A)

THERMAL IMAGING FUNDAMENTALS AND METHODOLOGY

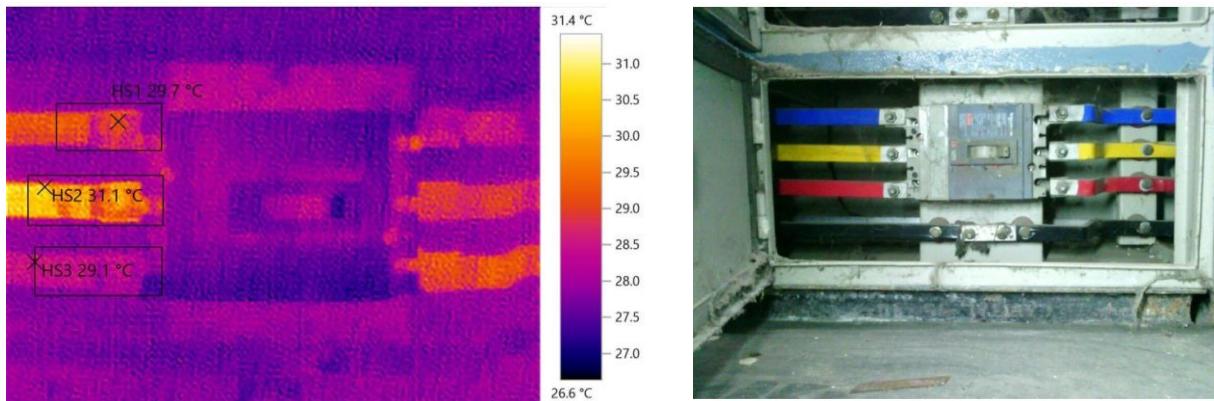
SR004564 Admin Building Main Panel, Feeder-2F7
Spare-1

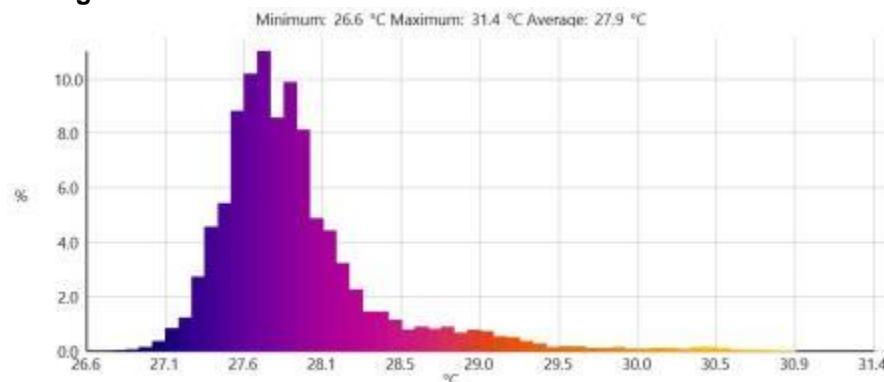
Analysis and Recommended Action	Observation: In the above picture marking the temperature difference between HS1 and HS3 (ΔT) is 0.6°C and HS2 and HS3 (ΔT) is 2.1°C. The thermograph is classified under Normal .
----------------------------------------	----------------------------------------------------------------------------------------------------------------------------------------------------------------------------------------------------------------------

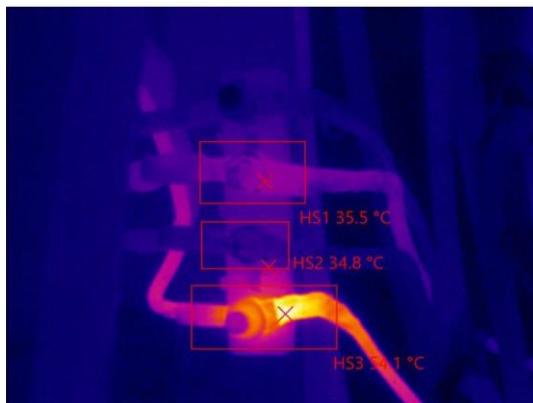
SR004565 Admin Building Main Panel, Feeder-2F3
Auditorium

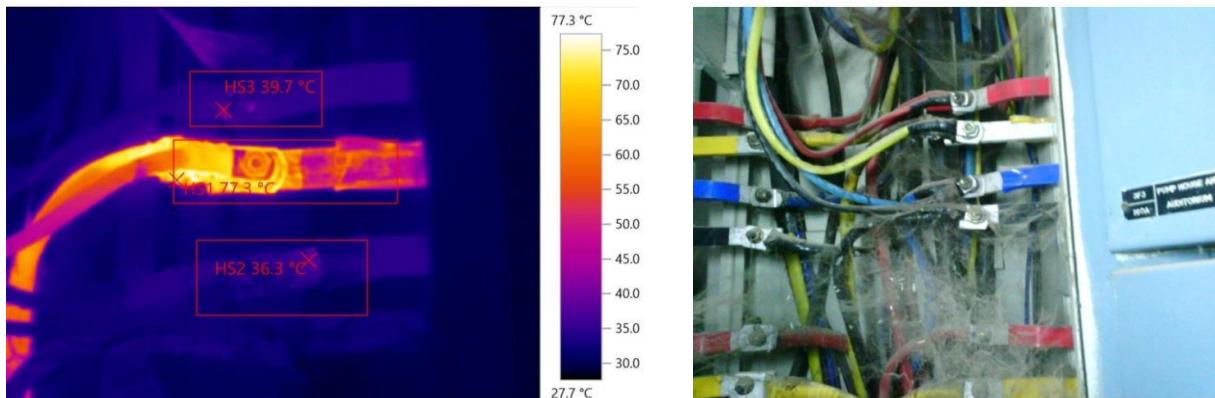
SR004566 Admin Building Main Panel, Feeder-3F3
Pump house outgoing

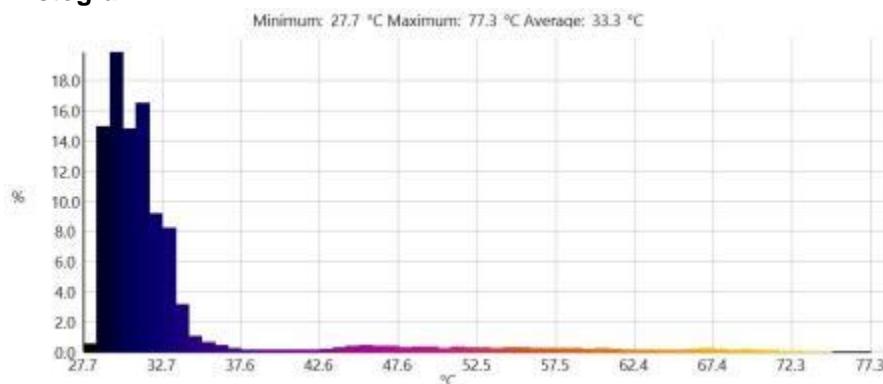
Analysis and Recommended Action	<p>Observation: In the above picture marking the temperature difference between HS1 and HS2 (ΔT) is 41.0°C and HS2 and HS3 (ΔT) is 3.4°C. The thermograph is classified under Alarming.</p> <p>Recommendation: The Y phase is experiencing heating due to the maximum load. It is recommended to balance the load across all phases and retighten the connection of Y phase.</p>
----------------------------------------	---------------------------------------------------------------------------------------------------------------------------------------------------------------------------------------------------------------------------------------------------------------------------------------------------------------------------------------------------------------------------------------------------------------------------------------------

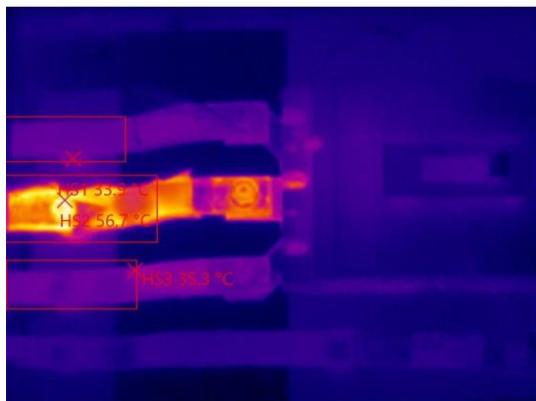
SR004568 Admin Building Main Panel, Feeder-3F3
Pump house MCCB Outlet

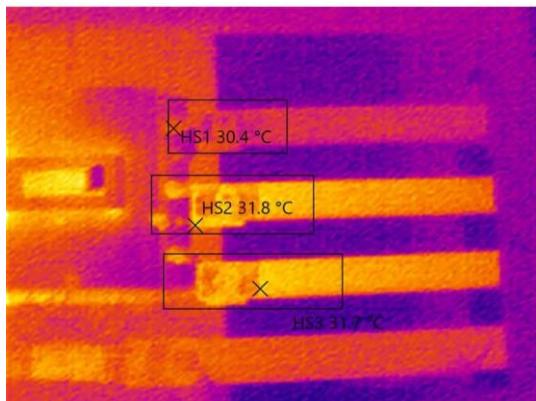
SR004569 Admin Building Main Panel, Feeder-3F3
Pump house MCCB Inlet

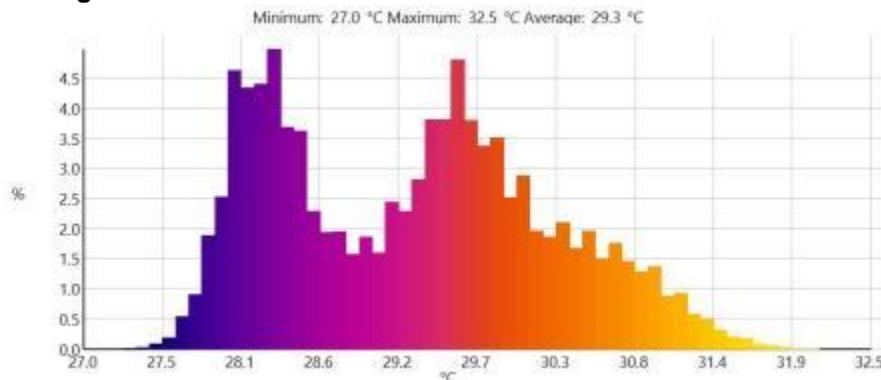
Analysis and Recommended Action	Observation: In the above picture marking the temperature difference between HS1 and HS2 (ΔT) is 1.4°C and HS1 and HS3 (ΔT) is 1.3°C. The thermograph is classified under Normal .
----------------------------------------	----------------------------------------------------------------------------------------------------------------------------------------------------------------------------------------------------------------------

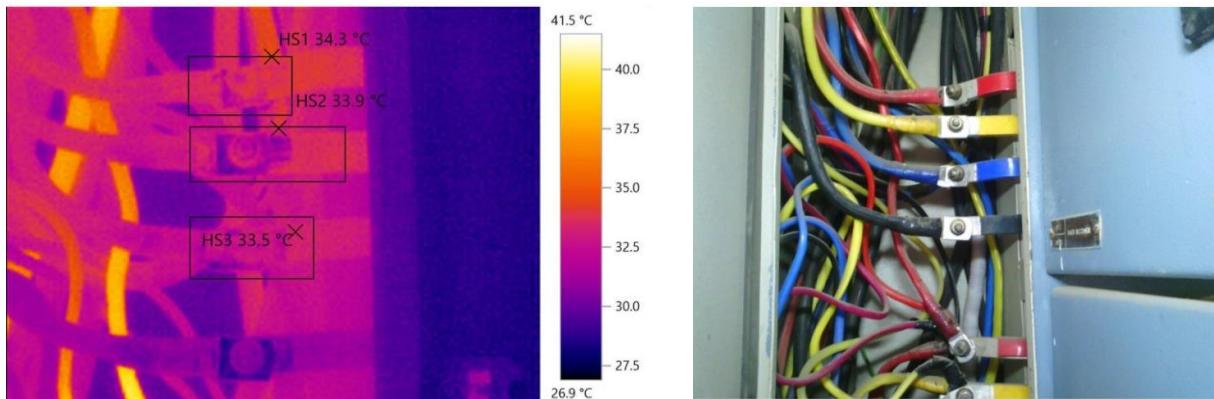
SR004570 Canteen Sub Main Panel-2, Main Incoming

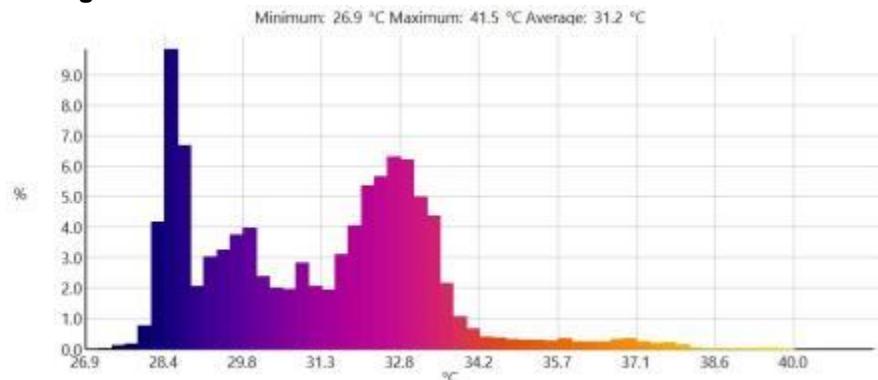
Analysis and Recommended Action	Observation: In the above picture marking the temperature difference between HS1 and HS3 (ΔT) is 0.8°C and HS2 and HS3 (ΔT) is 0.4°C. The thermograph is classified under Normal .
----------------------------------------	----------------------------------------------------------------------------------------------------------------------------------------------------------------------------------------------------------------------

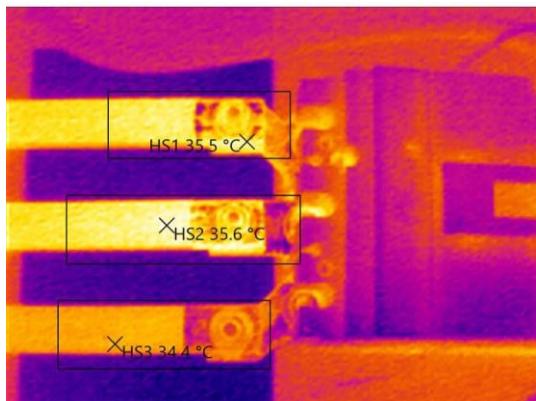
SR004571 Canteen Sub Main Panel-2, Main Incoming MCCB Inlet

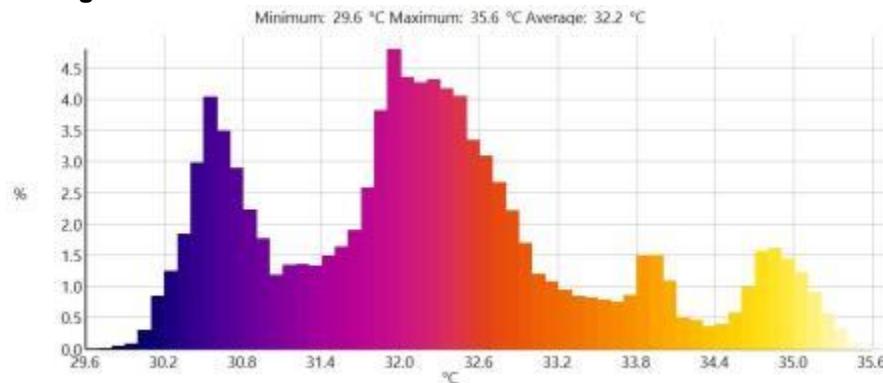
Analysis and Recommended Action	Observation: In the above picture marking the temperature difference between HS1 and HS3 (ΔT) is 1.1°C and HS2 and HS3 (ΔT) is 1.2°C. The thermograph is classified under Normal .
----------------------------------------	----------------------------------------------------------------------------------------------------------------------------------------------------------------------------------------------------------------------

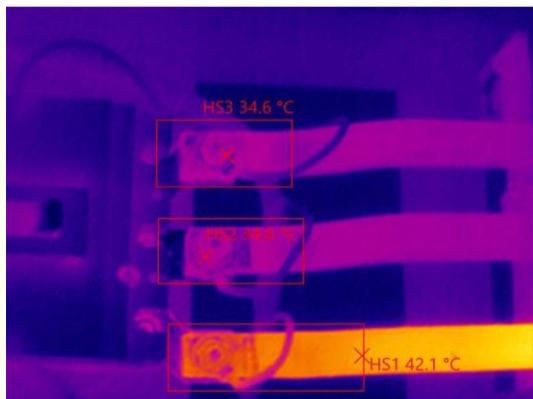
SR004572 Canteen Sub Main Panel-2, Main Incoming MCCB Outlet

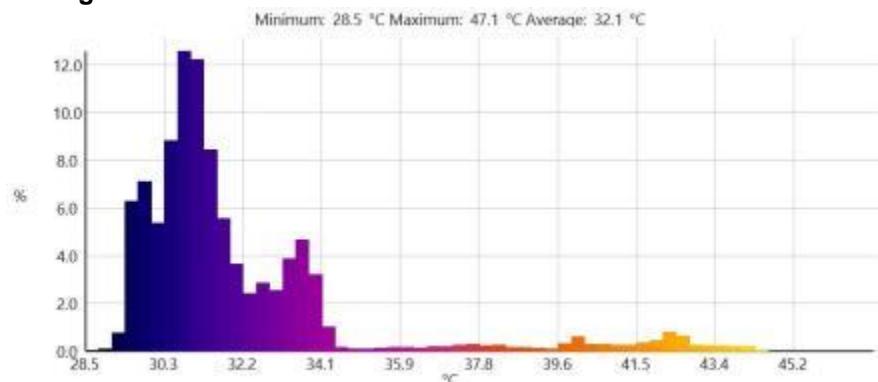
Analysis and Recommended Action	<p>Observation: In the above picture marking the temperature difference between HS1 and HS3 (ΔT) is 7.5°C and HS2 and HS3 (ΔT) is 0.0°C. The thermograph is classified under Caution.</p> <p>Recommendation: Heating was observed on the B phase. It is recommended to retighten the connection of B phase.</p>
----------------------------------------	----------------------------------------------------------------------------------------------------------------------------------------------------------------------------------------------------------------------------------------------------------------------------------------------------------------------------------------------------------------------------

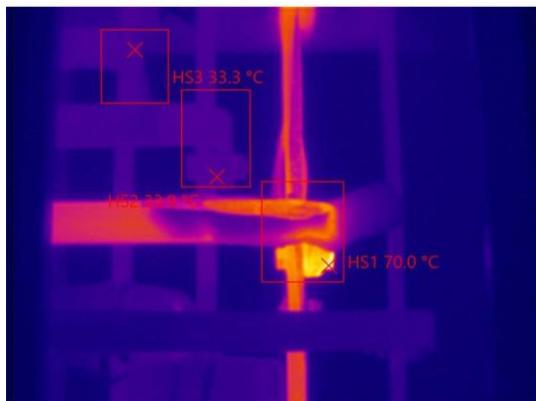
SR004573 Canteen Sub Main Panel-2, Feeder-1F2
Connected Bus bar

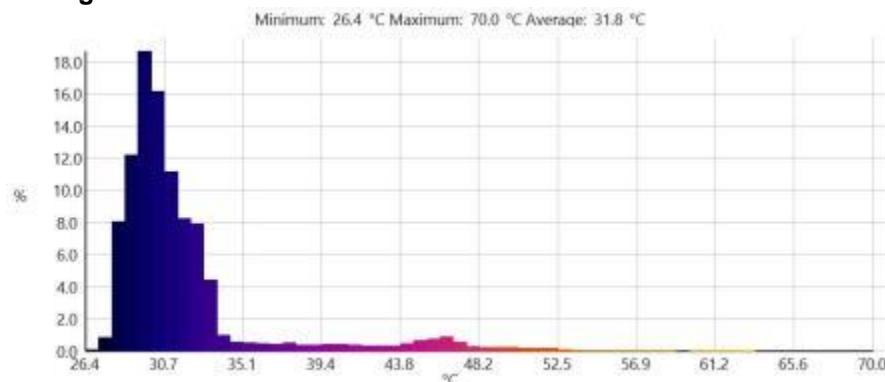
Analysis and Recommended Action	<p>Observation: In the above picture marking the temperature difference between HS1 and HS3 (ΔT) is 36.7°C and HS2 and HS3 (ΔT) is 0.6°C. The thermograph is classified under Alarming.</p> <p>Recommendation: Heating was observed on the B phase bus bar. It is recommended to retighten the connection of B phase bus bar.</p>
----------------------------------------	----------------------------------------------------------------------------------------------------------------------------------------------------------------------------------------------------------------------------------------------------------------------------------------------------------------------------------------------------------------------------------------------------------------------------------------------------

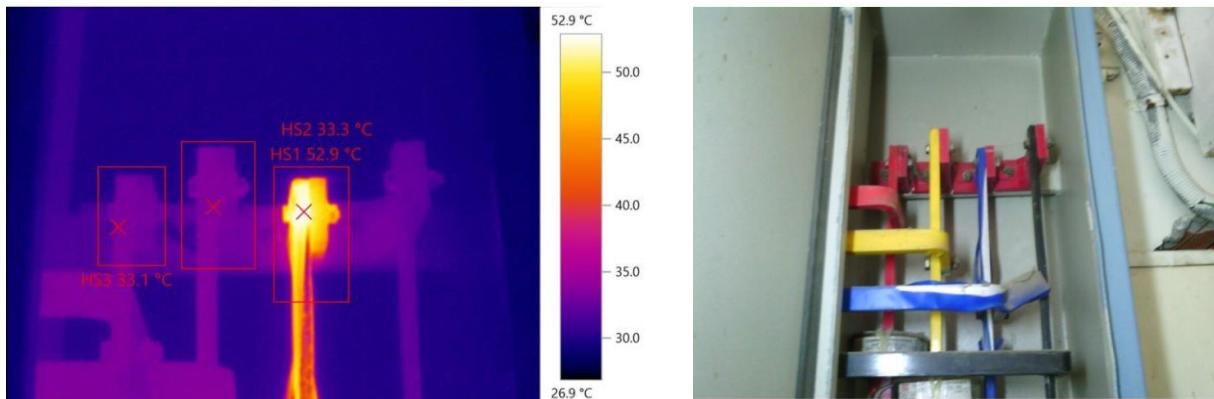
SR004574 Canteen Sub Main Panel-2, Feeder-1F2
Connected Bus bar

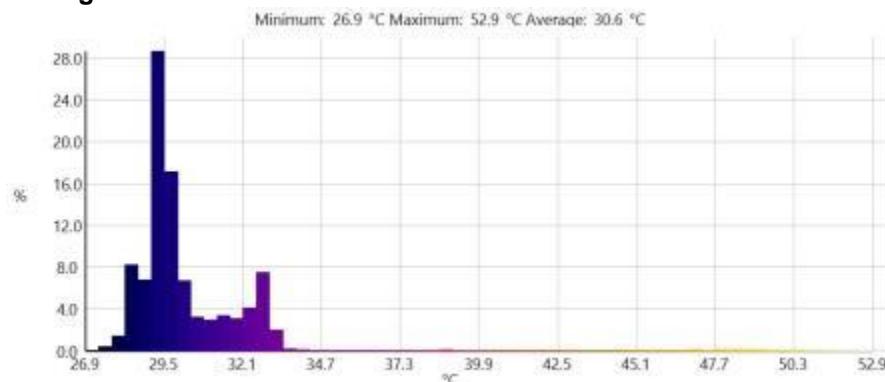
Analysis and Recommended Action	<p>Observation: In the above picture marking the temperature difference between HS1 and HS3 (ΔT) is 19.8°C and HS2 and HS3 (ΔT) is 0.2°C. The thermograph is classified under Alarming.</p> <p>Recommendation: Heating was observed on the B phase bus bar. It is recommended to retighten the connection of B phase bus bar.</p>
----------------------------------------	----------------------------------------------------------------------------------------------------------------------------------------------------------------------------------------------------------------------------------------------------------------------------------------------------------------------------------------------------------------------------------------------------------------------------------------------------

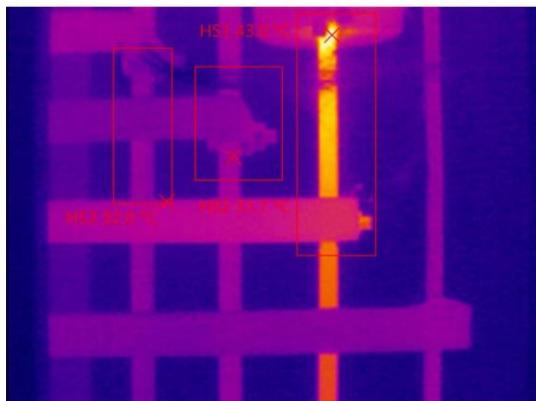
SR004575 Canteen Sub Main Panel-2, Feeder-1F2
Connected Busbar

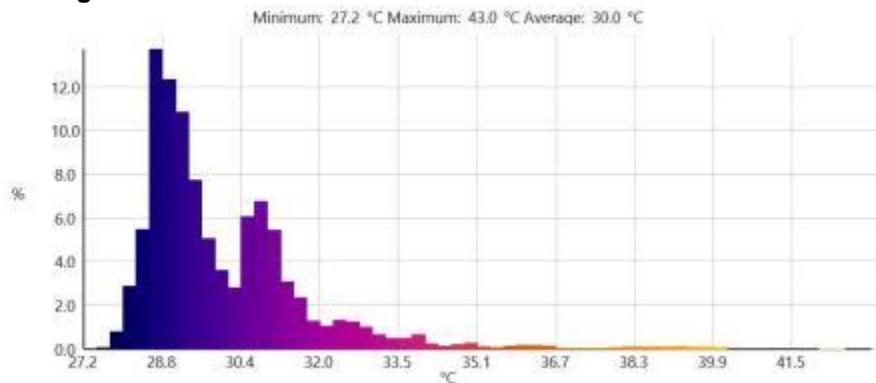
Analysis and Recommended Action	<p>Observation: In the above picture marking the temperature difference between HS1 and HS2 (ΔT) is 11.3°C and HS2 and HS3 (ΔT) is 0.3°C. The thermograph is classified under Caution.</p> <p>Recommendation: Heating was observed on the B phase. It is recommended to retighten the connection of B phase.</p>
----------------------------------------	-----------------------------------------------------------------------------------------------------------------------------------------------------------------------------------------------------------------------------------------------------------------------------------------------------------------------------------------------------------------------------------------------------------------------------------

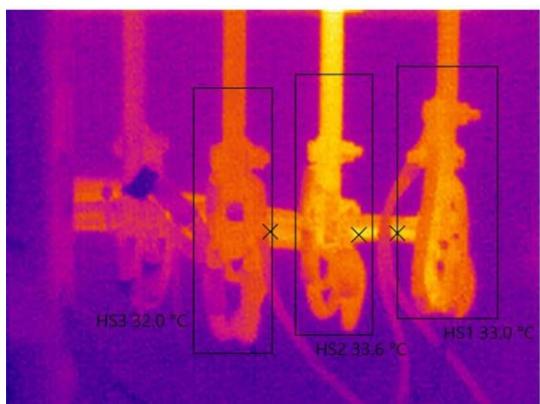
SR004576 Canteen Sub Main Panel-2, Feeder-1F2
Connected Bus bar

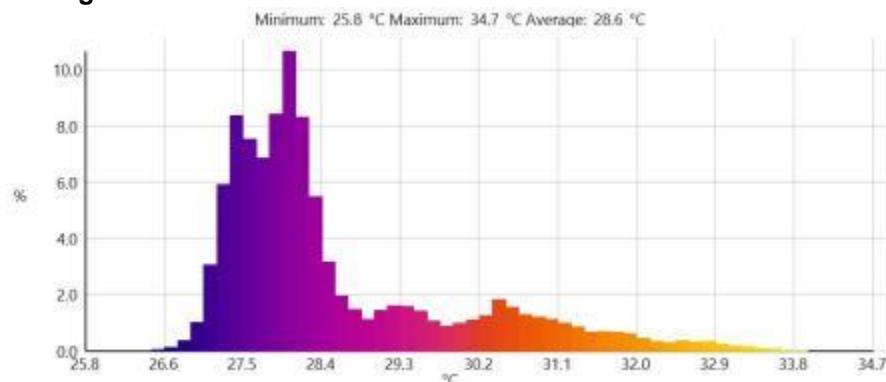
Analysis and Recommended Action	Observation: In the above picture marking the temperature difference between HS1 and HS3 (ΔT) is 1.0°C and HS2 and HS3 (ΔT) is 1.6°C. The thermograph is classified under Normal .
----------------------------------------	----------------------------------------------------------------------------------------------------------------------------------------------------------------------------------------------------------------------

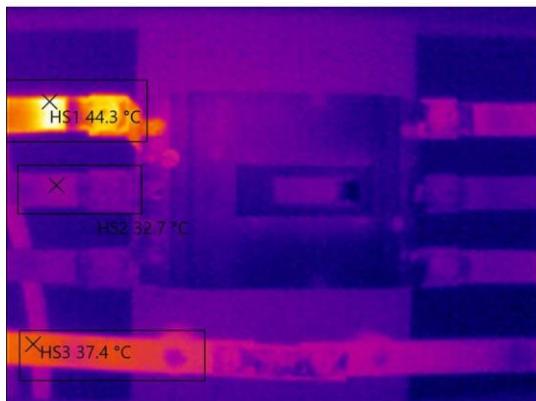
**SR004577 Canteen Sub Main Panel-2, Feeder-1F3
New office, Lab 1 and 2 Server room connected
MCB inlet**

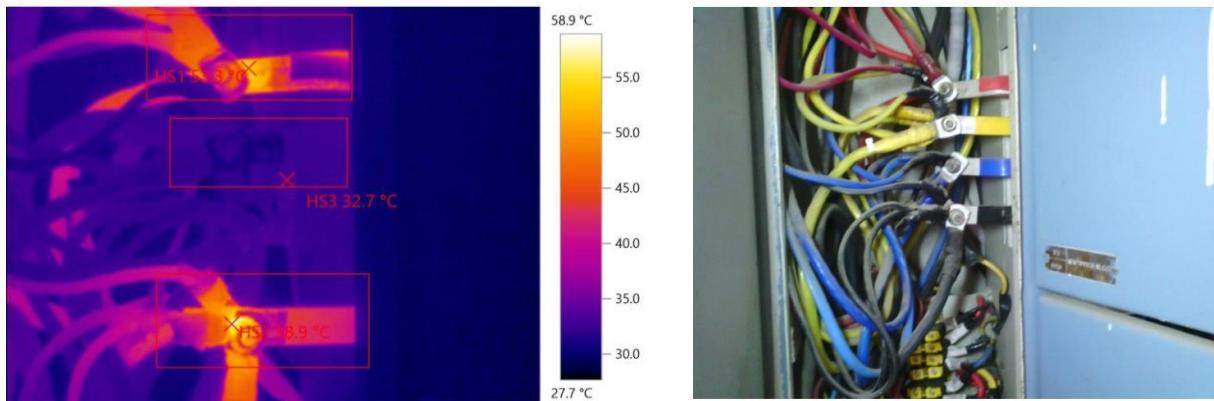
SR004578 Canteen Sub Main Panel-2, Feeder-1F3
New office, Lab 1 and 2 Server room Outgoing

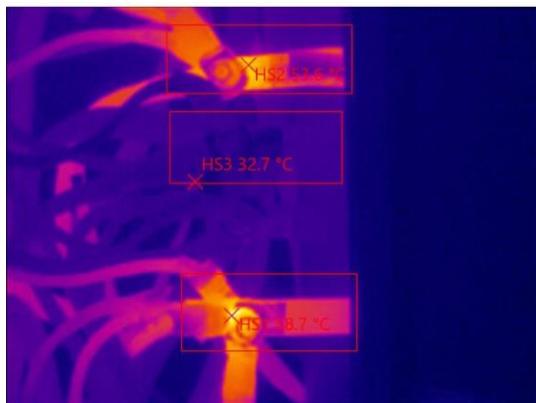
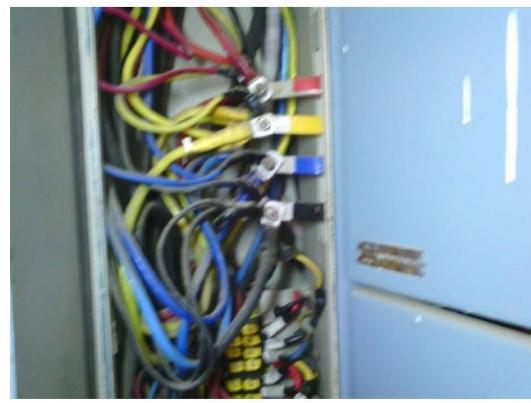
SR004579 Canteen Sub Main Panel-2, Feeder-1F3
New office, Lab 1 and 2 Server room Outgoing

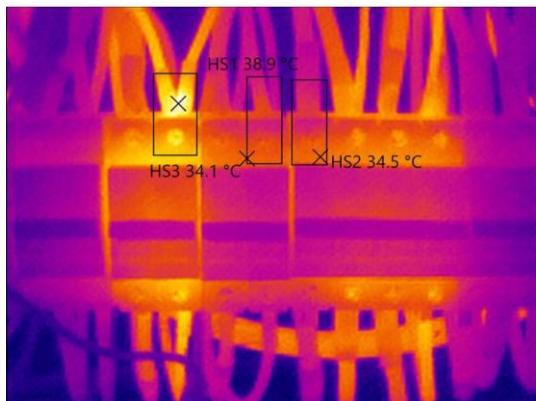
SR004580 Canteen Sub Main Panel-2, Feeder-1F4
Distribution Panel

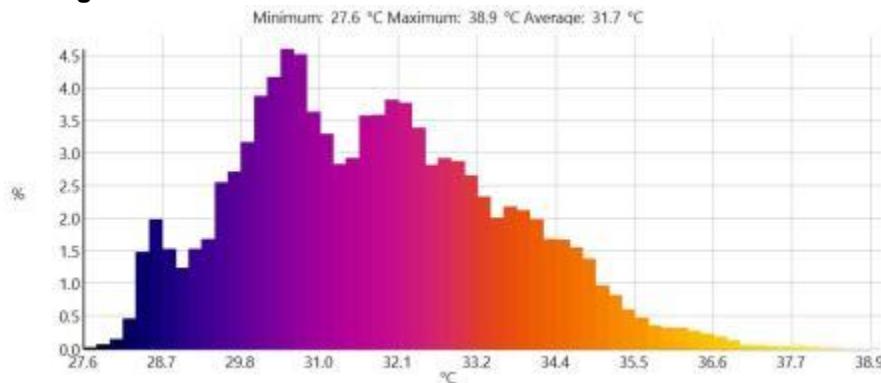
Analysis and Recommended Action	<p>Observation: In the above picture marking the temperature difference between HS1 and HS3 (ΔT) is 4.8°C and HS2 and HS3 (ΔT) is 0.4°C. The thermograph is classified under Caution.</p> <p>Recommendation: Heating was observed on the Neutral phase. It is recommended to retighten the connection of Neutral phase. It is recommended to re-crimp the Neutral phase.</p>
----------------------------------------	-----------------------------------------------------------------------------------------------------------------------------------------------------------------------------------------------------------------------------------------------------------------------------------------------------------------------------------------------------------------------------------------------------------------------------------------

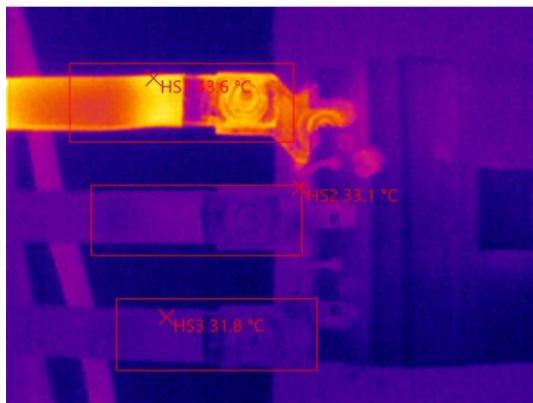
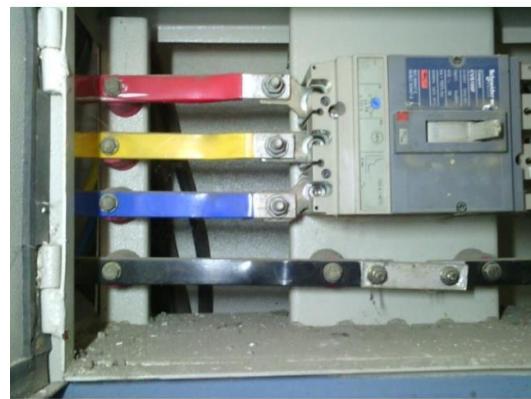
**SR004581 Canteen Sub Main Panel-2, Feeder-1F3
new office, Lab 1 and 2 Server room connected
MCB Outlet**

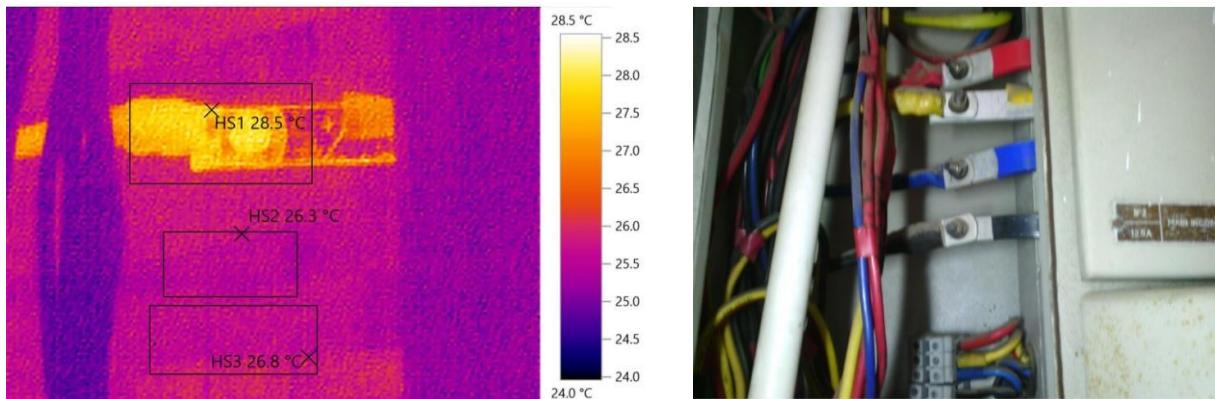
SR004585 First Floor Sub Main Panel-7, Feeder-1F2 Main Incoming

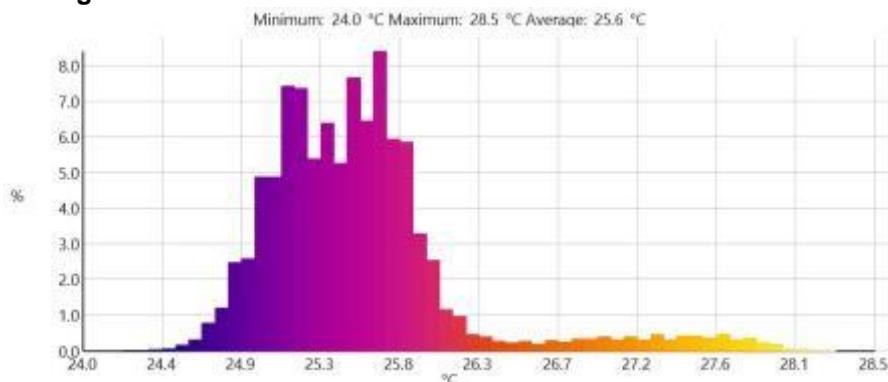
Analysis and Recommended Action	Observation: In the above picture marking the temperature difference between HS1 and HS2 (ΔT) is 2.2°C and HS2 and HS3 (ΔT) is 0.5°C. The thermograph is classified under Normal .
----------------------------------------	----------------------------------------------------------------------------------------------------------------------------------------------------------------------------------------------------------------------

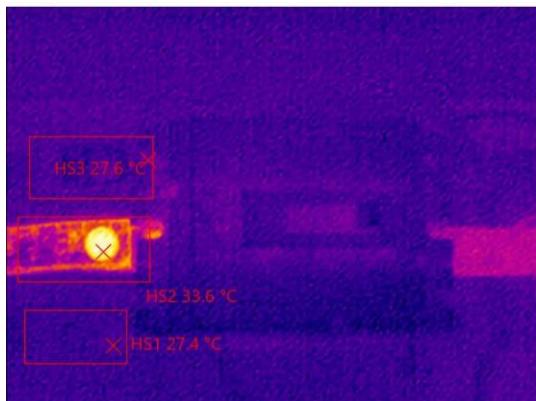
SR004586 First Floor Sub Main Panel-7, Feeder-1F2 Main Incoming MCCB

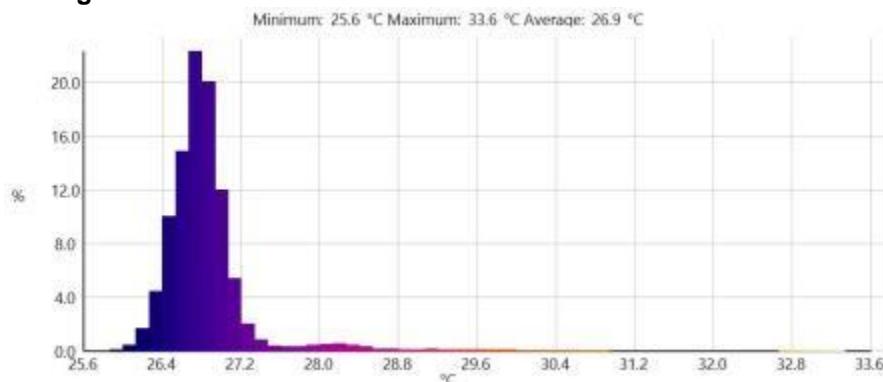
Analysis and Recommended Action	<p>Observation: In the above picture marking the temperature difference between HS1 and HS2 (ΔT) is 6.2°C and HS1 and HS3 (ΔT) is 0.2°C. The thermograph is classified under Caution.</p> <p>Recommendation: The Y phase is experiencing heating due to the maximum load. It is recommended to balance the load across all phases and retighten the connection of Y phase.</p>
----------------------------------------	-------------------------------------------------------------------------------------------------------------------------------------------------------------------------------------------------------------------------------------------------------------------------------------------------------------------------------------------------------------------------------------------------------------------------------------------

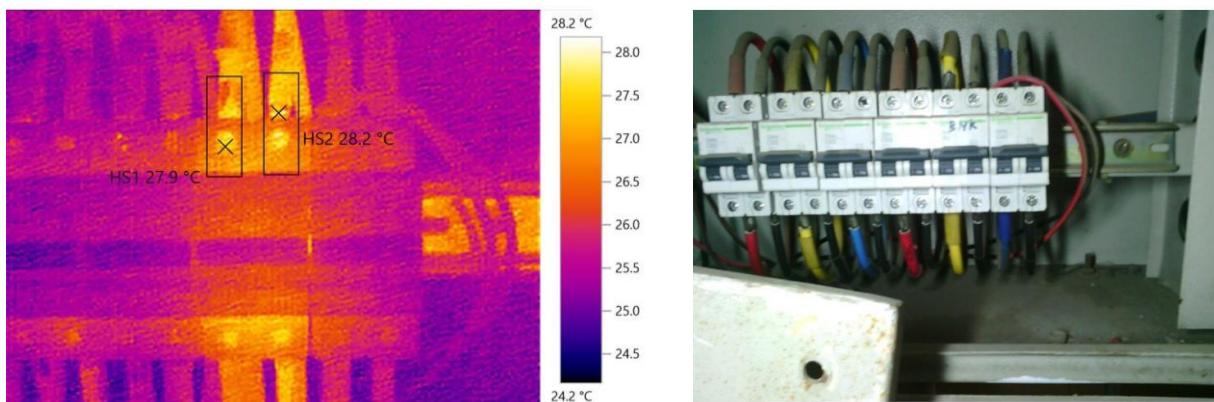
SR004587 First Floor Sub Main Panel-7, Feeder-1F4 Distribution Panel

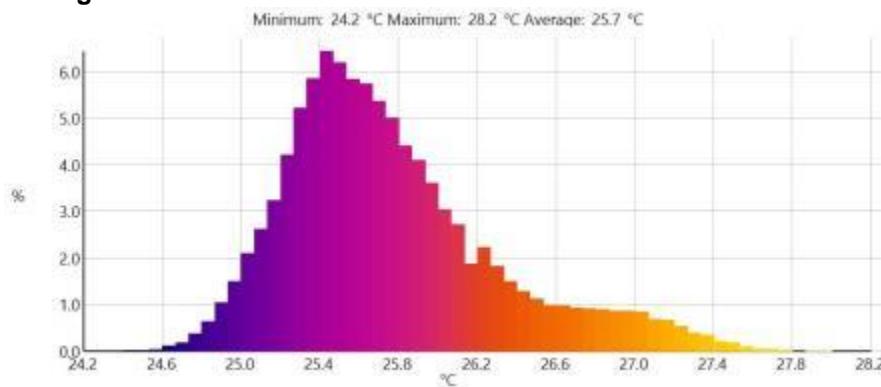
Analysis and Recommended Action	Observation: In the above picture marking the temperature difference between HS1 and HS2 (ΔT) is 0.3°C. The thermograph is classified under Normal .
----------------------------------------	------------------------------------------------------------------------------------------------------------------------------------------------------------------------------

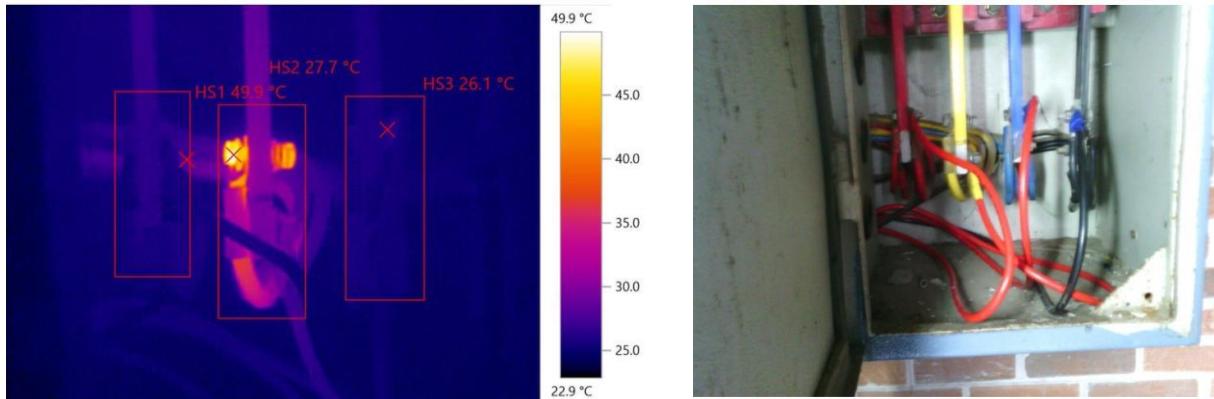
SR004589 Library Sub Main Panel-6, Feeder-1F4
Distribution Bus bar

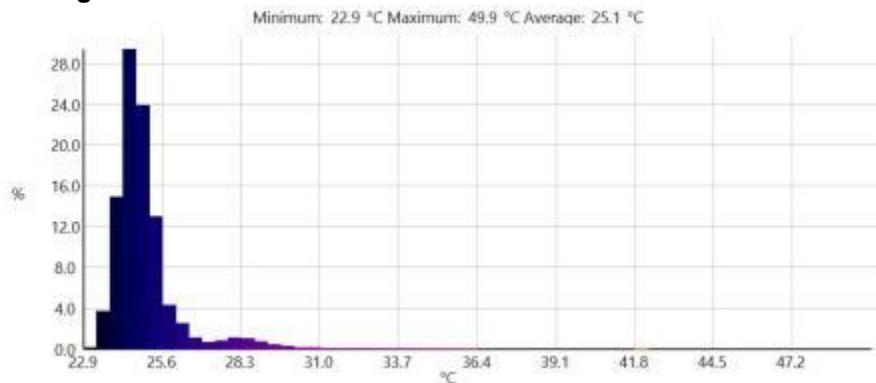
Analysis and Recommended Action	<p>Observation: In the above picture marking the temperature difference between HS1 and HS3 (ΔT) is 23.8°C and HS2 and HS3 (ΔT) is 1.6°C. The thermograph is classified under Alarming.</p> <p>Recommendation: Heating was observed on the Y phase bus bar. It is recommended to retighten the connection of Y phase bus bar.</p>
----------------------------------------	----------------------------------------------------------------------------------------------------------------------------------------------------------------------------------------------------------------------------------------------------------------------------------------------------------------------------------------------------------------------------------------------------------------------------------------------------

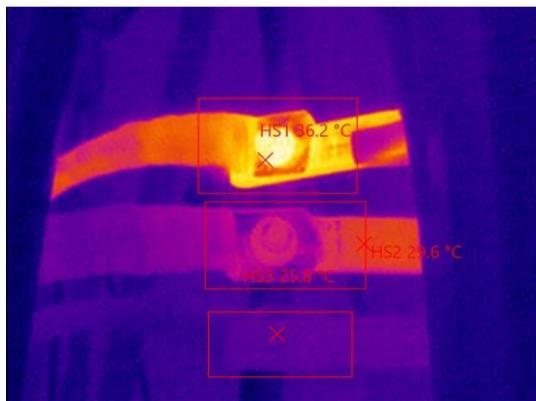
SR004590 Library Sub Main Panel-6, Feeder-1F2
Main Incoming

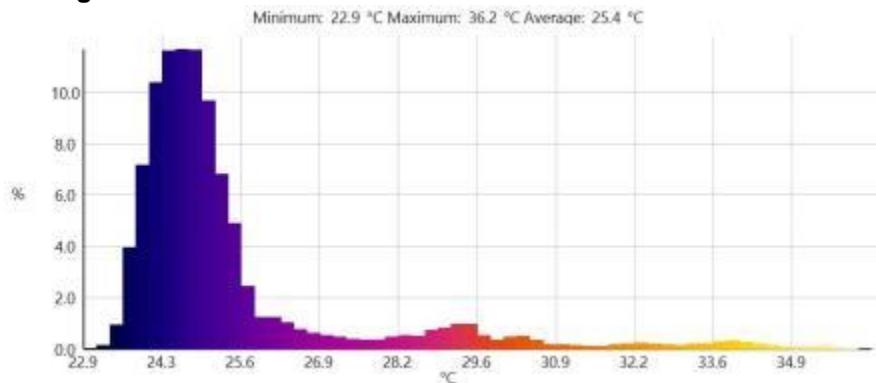
Analysis and Recommended Action	<p>Observation: In the above picture marking the temperature difference between HS1 and HS3 (ΔT) is 10.4°C and HS2 and HS3 (ΔT) is 3.8°C. The thermograph is classified under Caution.</p> <p>Recommendation: Heating was observed on the R phase. It is recommended to retighten the connection of R phase.</p>
----------------------------------------	-----------------------------------------------------------------------------------------------------------------------------------------------------------------------------------------------------------------------------------------------------------------------------------------------------------------------------------------------------------------------------------------------------------------------------------

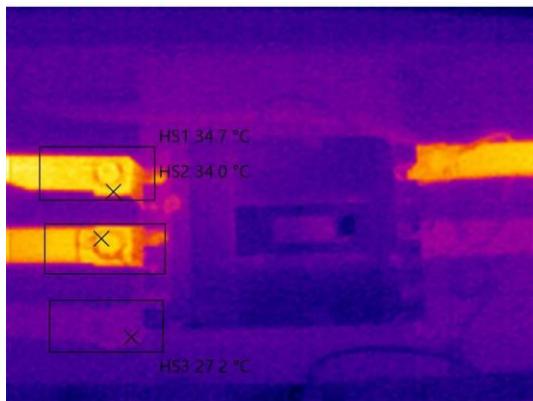
SR004591 Library Sub Main Panel-6, Feeder-1F2
Main Incoming MCCB

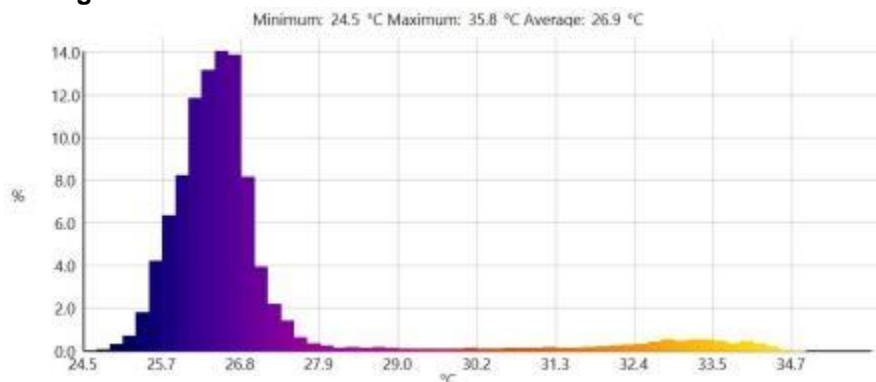
Analysis and Recommended Action	<p>Observation: In the above picture marking the temperature difference between HS1 and HS3 (ΔT) is 7.5°C and HS2 and HS3 (ΔT) is 6.8°C. The thermograph is classified under Caution.</p> <p>Recommendation: Heating was observed on the R and Y phase. It is recommended to retighten the connection of R and Y phase.</p>
----------------------------------------	----------------------------------------------------------------------------------------------------------------------------------------------------------------------------------------------------------------------------------------------------------------------------------------------------------------------------------------------------------------------------------------

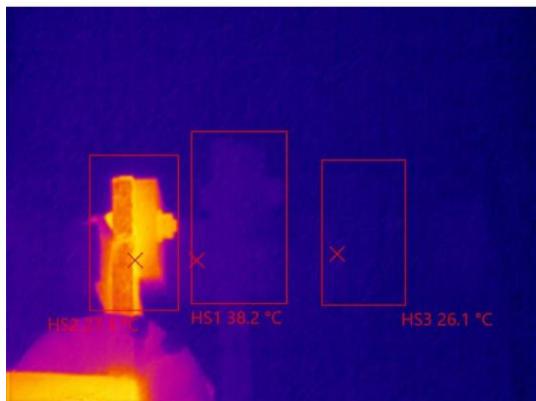
SR004592 Library Sub Main Panel-6, Feeder-1F2
Distribution Bus bar

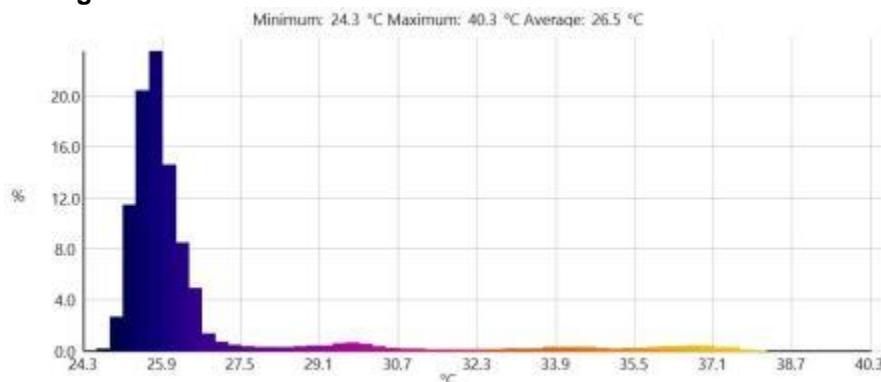
Analysis and Recommended Action	<p>Observation: In the above picture marking the temperature difference between HS1 and HS3 (ΔT) is 12.1°C and HS2 and HS3 (ΔT) is 1.0°C. The thermograph is classified under Caution.</p> <p>Recommendation: Heating was observed on the R phase bus bar. It is recommended to retighten the connection of R phase bus bar.</p>
----------------------------------------	---------------------------------------------------------------------------------------------------------------------------------------------------------------------------------------------------------------------------------------------------------------------------------------------------------------------------------------------------------------------------------------------

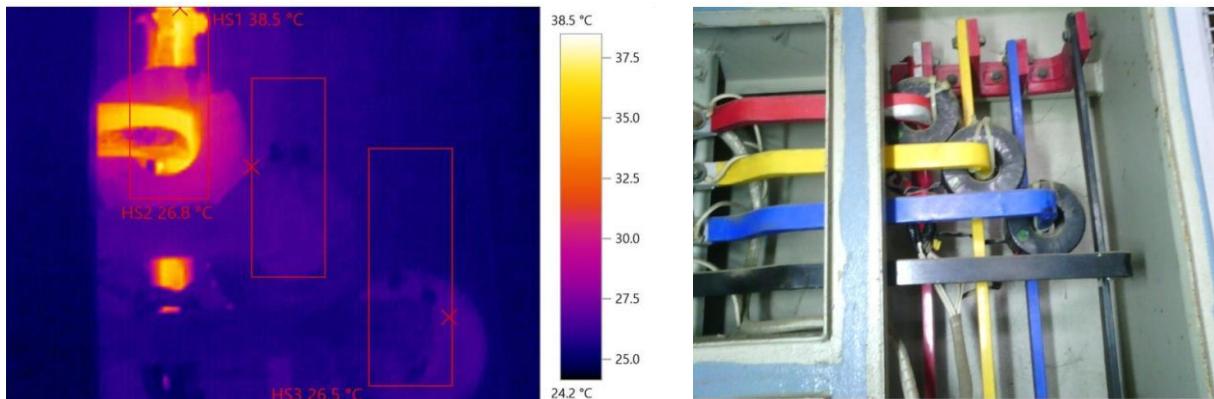
SR004593 Library Sub Main Panel-6, Feeder-1F2
Distribution Busbar

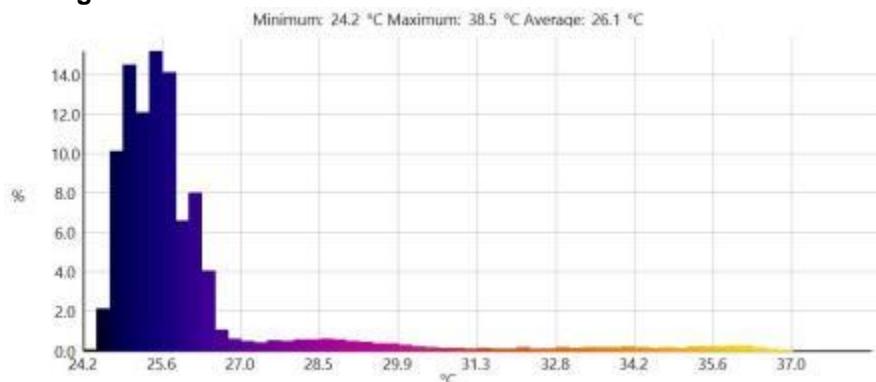
Analysis and Recommended Action	<p>Observation: In the above picture marking the temperature difference between HS1 and HS3 (ΔT) is 12.0°C and HS2 and HS3 (ΔT) is 0.3°C. The thermograph is classified under Caution.</p> <p>Recommendation: Heating was observed on the R phase bus bar. It is recommended to retighten the connection of R phase bus bar.</p>
----------------------------------------	---------------------------------------------------------------------------------------------------------------------------------------------------------------------------------------------------------------------------------------------------------------------------------------------------------------------------------------------------------------------------------------------

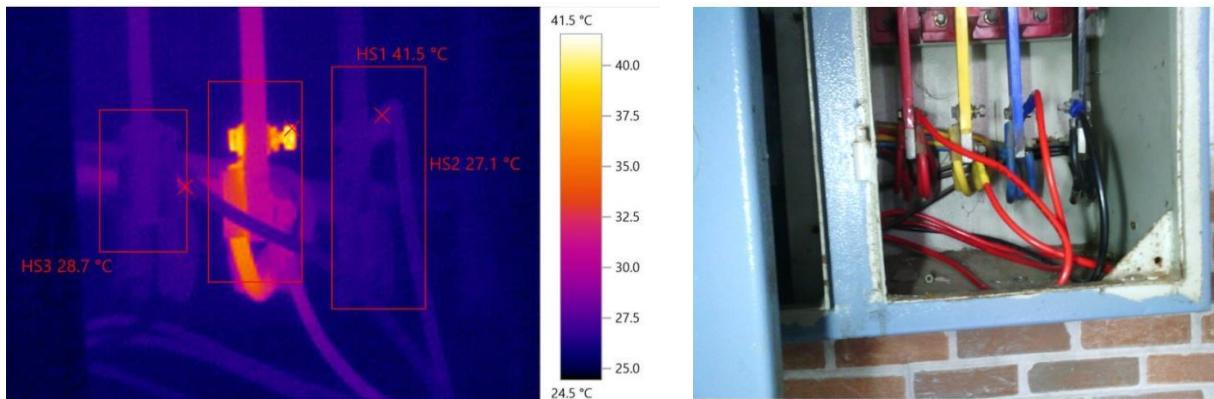
SR004594 Library Sub Main Panel-6, Feeder-1F4
Distribution Bus bar

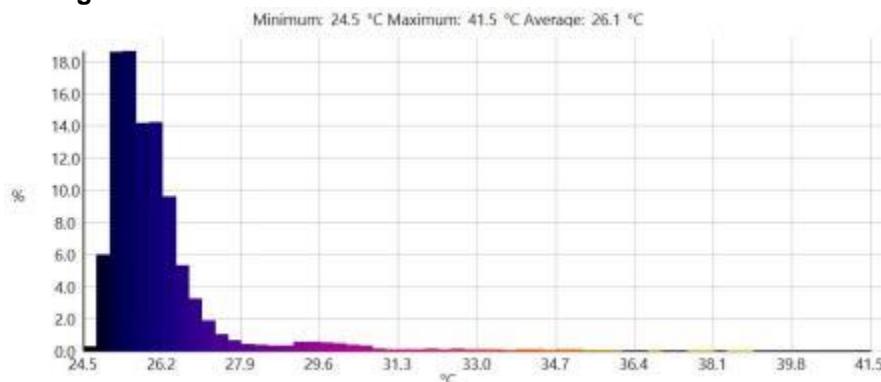
Analysis and Recommended Action	<p>Observation: In the above picture marking the temperature difference between HS1 and HS2 (ΔT) is 14.4°C and HS2 and HS3 (ΔT) is 1.6°C. The thermograph is classified under Alarming.</p> <p>Recommendation: Heating was observed on the Y phase bus bar. It is recommended to retighten the connection of Y phase bus bar.</p>
----------------------------------------	----------------------------------------------------------------------------------------------------------------------------------------------------------------------------------------------------------------------------------------------------------------------------------------------------------------------------------------------------------------------------------------------------------------------------------------------------

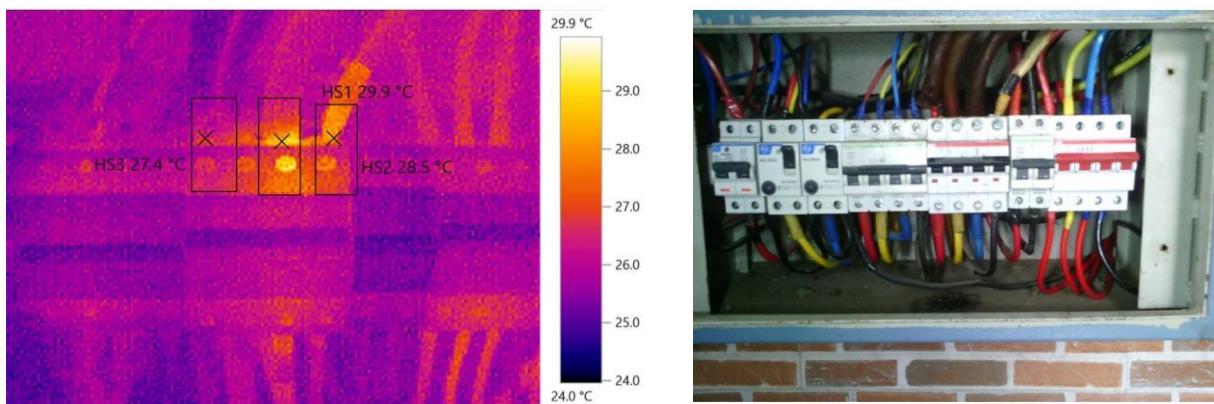
SR004595 Library Sub Main Panel-6, Feeder-1F4
Distribution MCB

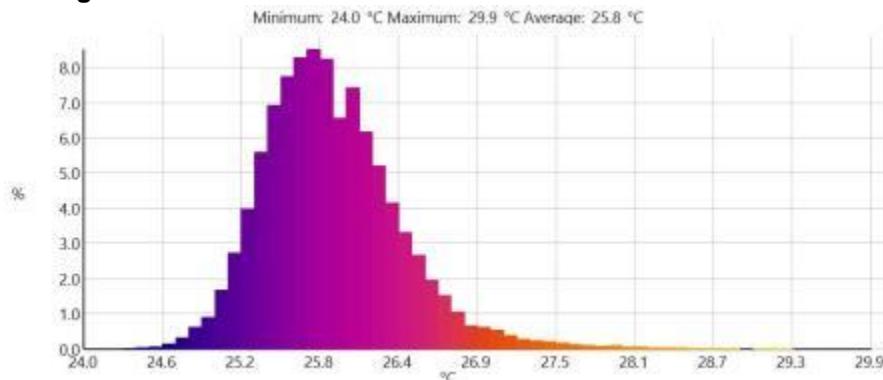
Analysis and Recommended Action	Observation: In the above picture marking the temperature difference between HS1 and HS3 (ΔT) is 2.5°C and HS2 and HS3 (ΔT) is 1.1°C. The thermograph is classified under Normal .
----------------------------------------	----------------------------------------------------------------------------------------------------------------------------------------------------------------------------------------------------------------------

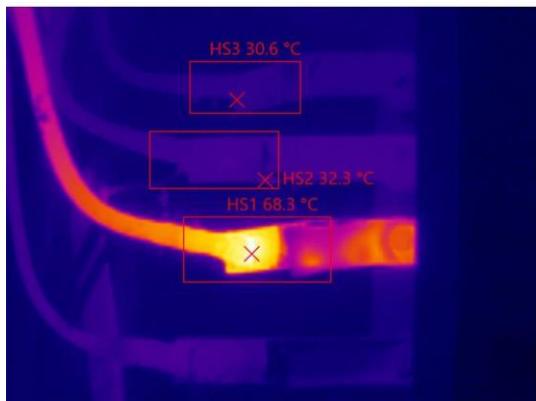
SR004596 Auditorium Main Panel, Feeder-1F2
Main Incoming

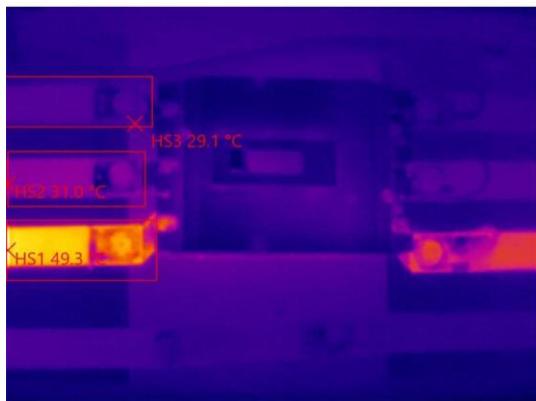
SR004598 Auditorium Main Panel, Feeder-1F2
Main Incoming MCCB Inlet

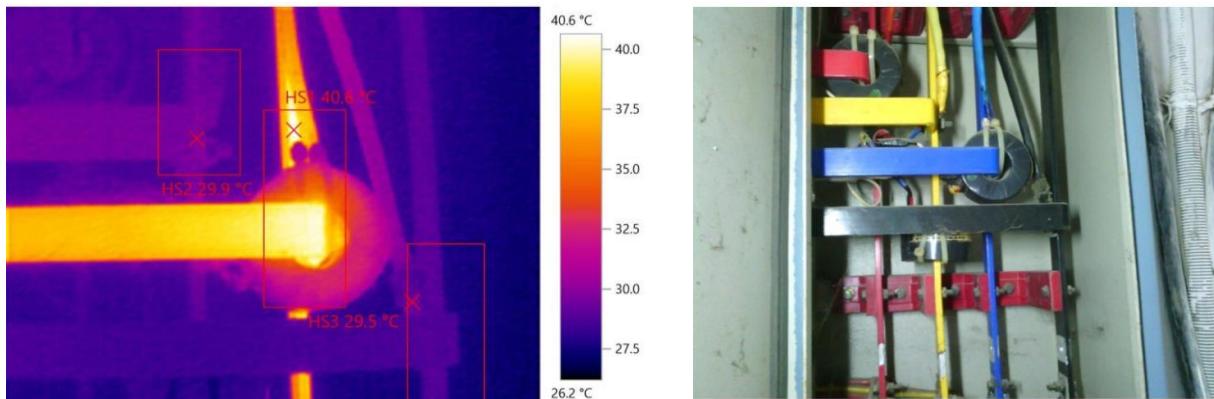
SR004599 Auditorium Main Panel, Feeder-1F2
Main Incoming MCCB outlet

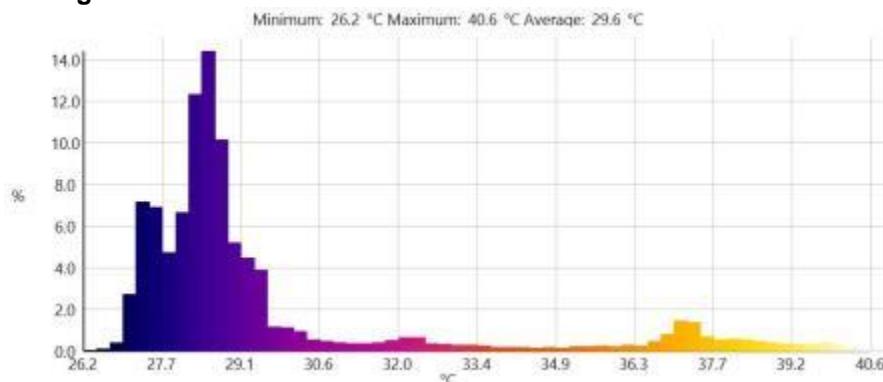
Analysis and Recommended Action	<p>Observation: In the above picture marking the temperature difference between HS1 and HS3 (ΔT) is 11.1°C and HS2 and HS3 (ΔT) is 0.4°C. The thermograph is classified under Caution.</p> <p>Recommendation: The B phase is experiencing heating due to the maximum load. It is recommended to balance the load across all phases and to retighten the connection of B phase.</p>
----------------------------------------	-----------------------------------------------------------------------------------------------------------------------------------------------------------------------------------------------------------------------------------------------------------------------------------------------------------------------------------------------------------------------------------------------------------------------------------------------

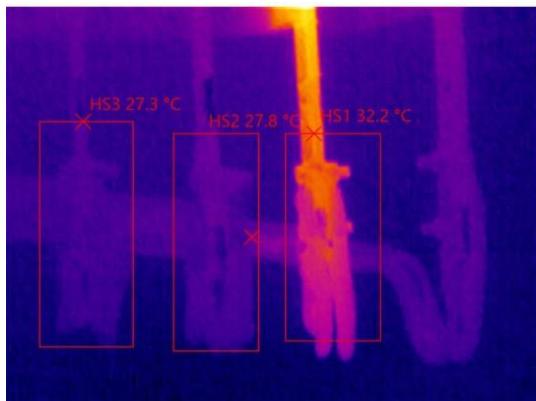
SR004600 Auditorium Main Panel, Feeder-1F3
Distribution Bus bar
