ANNEXTURE (A)

THERMAL IMAGING FUNDAMENTALS AND METHODOLOGY

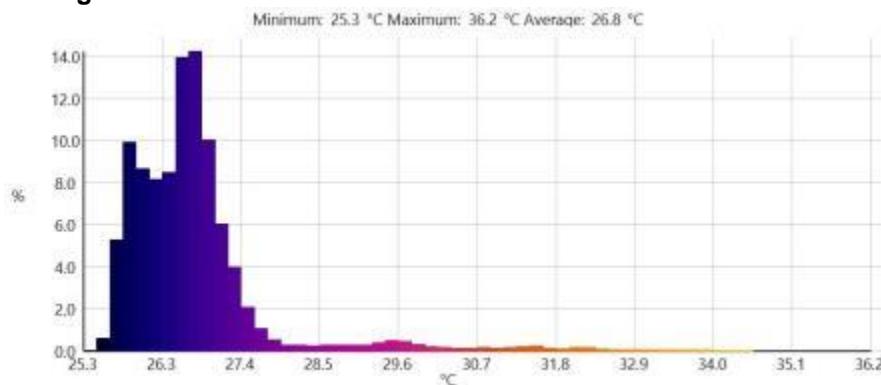
Analysis and Recommended Action	<p>Observation: In the above picture marking the temperature difference between HS1 and HS3 (ΔT) is 4.9°C and HS2 and HS3 (ΔT) is 0.5°C. The thermograph is classified under Caution.</p> <p>Recommendation: Heating was observed on the B phase. It is recommended to retighten the connection of B phase.</p>
----------------------------------------	----------------------------------------------------------------------------------------------------------------------------------------------------------------------------------------------------------------------------------------------------------------------------------------------------------------------------------------------------------------------------

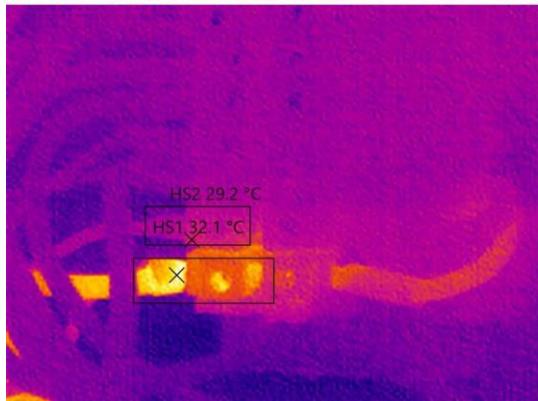
SR004601 Auditorium Main Panel, Feeder-1F3
Distribution Panel outgoing

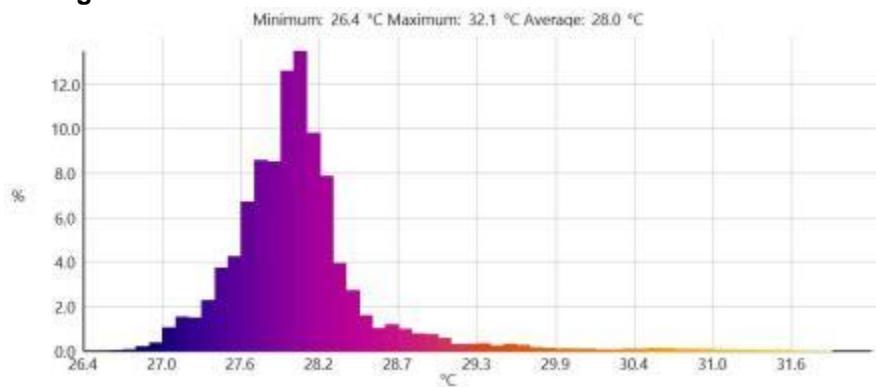
Analysis and Recommended Action	Observation: In the above picture marking the temperature difference between HS1 and HS2 (ΔT) is 2.9°C. The thermograph is classified under Normal .
----------------------------------------	------------------------------------------------------------------------------------------------------------------------------------------------------------------------------
